Corymbia Consulting
Arboricultural Consultants

Tree assessment of two *Lophostemon confertus* on the verge of 48 Milton Street, Mt Hawthorn.

Mark Short, Grad Cert Arb, Dip Arb
12/03/2018

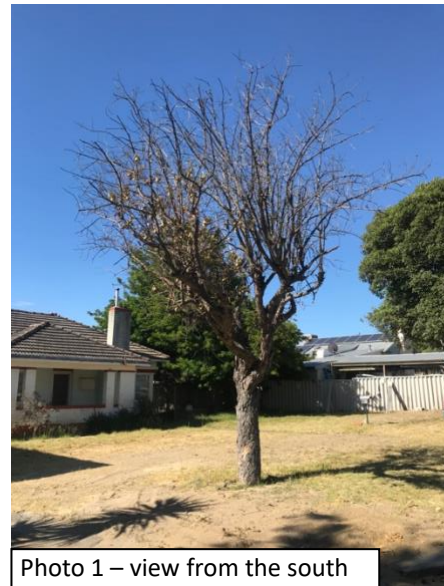
Photo 1 – view from the south

The root zone of tree 1 was found to have been disturbed in recent times, with excavation appearing to have been carried out recently for the installation of underground power (Photo 1 & 2). This is evidenced by sand on the verge between the road and tree, where a pit has been dug to facilitate under road boring to the power pole on the opposite side of the road. Excavation has been undertaken to the North East of tree 2 to install the new power dome. This excavation is 6.5m from the tree which is outside of its structural root zone.

Tree 1 was found to have diminished signs of life with little cambial activity. It is not known if the excavation has had anything to do with its decline.

Tree 1 was found to be in poor condition and is effectively moribund. It would be recommended to remove this tree and replace it with a species in line with the City of Vincent's street tree planting list. The tree should ideally be of a 100 litre bag size. The new tree should be watered for a minimum of two summers following planting with a minimum of 150 litres of water per week.

- That tree 1 be removed and a replacement be planted following completion of construction at a minimum distance of 2m from the new driveway.
- That the new tree be watered for 2 summers following planting with a minimum of 150 litres of water per week.
- That tree 2 be retained and protected
- That tree 2 receive supplemental watering as described in section 8.0
- That protection fencing be placed 0.5m around the outside of the canopy in order to allow for some usable area of the verge.
- That any required excavation is undertaken outside of the Structural Root Zone for Tree 1 (3.03m). With the exception of the additional crossover that will encroach the SRZ.
- That all excavation undertaken around the tree is done so in line with the methodology described in sections 9.0 and 9.1.

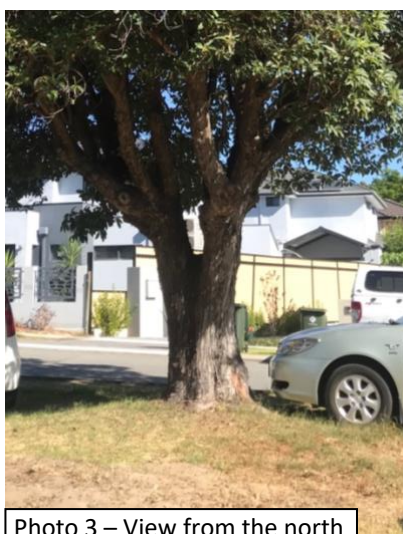
Photo 3 – View from the north

The root crown of tree 2 is showing signs of basal flare and the production of annualised response growth, indicating that these trees are maintaining a structurally firm root plate at this time. There is a road 2.7m to the south, with no signs of root damage from this tree, and A water meter is 4.7m to the North West (Photo 4). It is important this should any excavations be required around the water meter, they are not undertaken any closer than 3m from the tree.

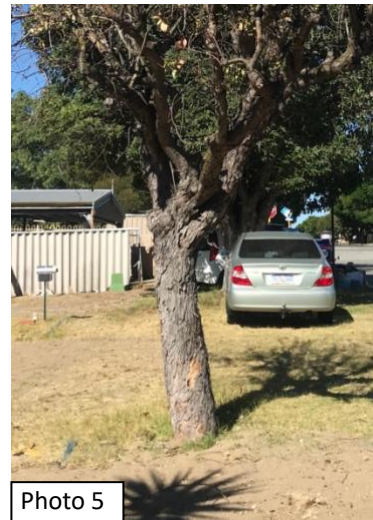
Photo 5

The trunk of tree 1 is showing minimal signs of cambial activity due to its decline in health.

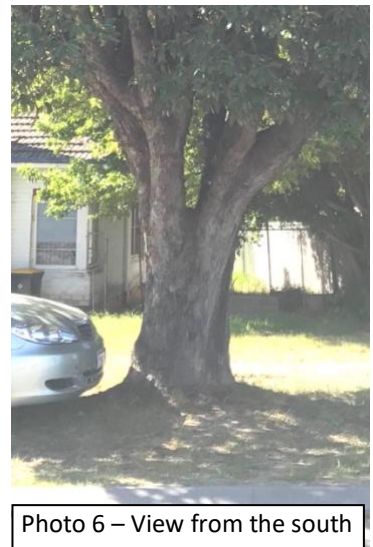
Photo 6 – View from the south

Tree 2 has a single trunk to a height of 1.5m where it bifurcates to form multiple leaders. The union of the bifurcation was found to be sound with little included bark. Sounding of this trunk with an acoustic hammer found it to have an adequate wall thickness at this time. The tree was observed to be applying annualised wood to maintain optimal structural integrity.

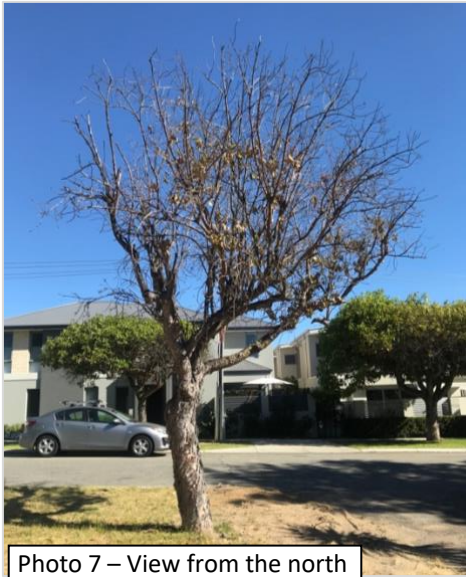
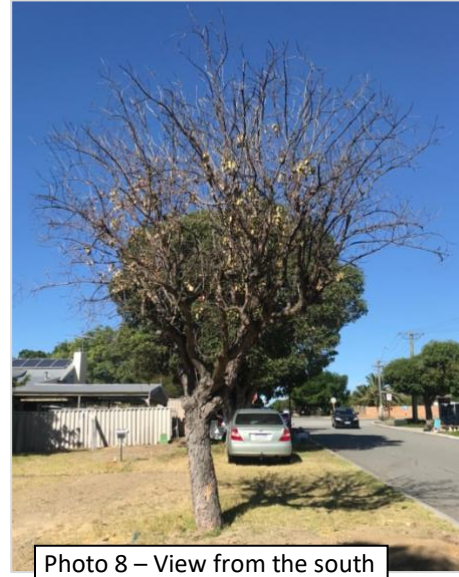
The canopy of tree 1 was observed to be in significant decline, with few living leaves. (photo 7 & 8)

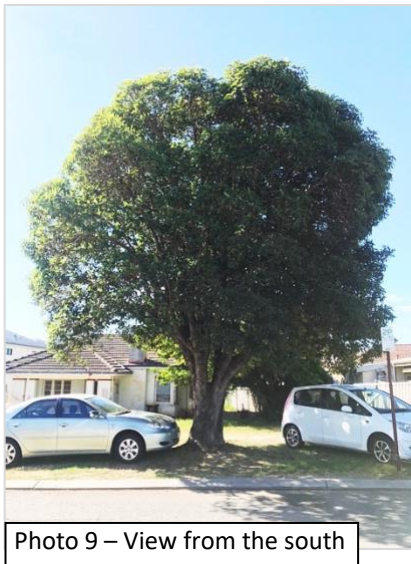
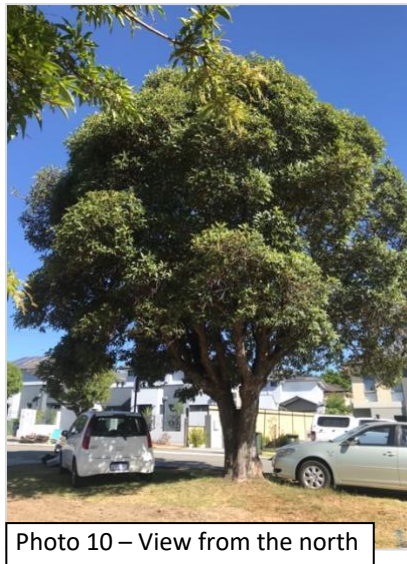
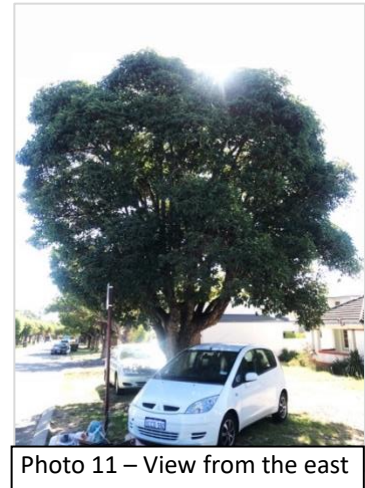
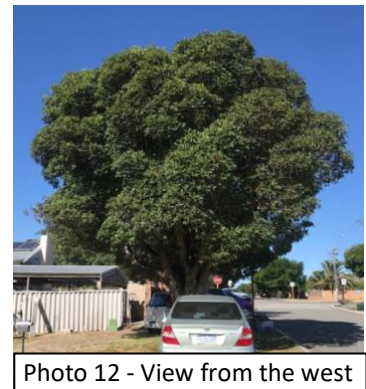
Tree 2 was found to have a normal density in its crown (photo 9, 10, 11 & 12) and displays a good level of health and condition. There were no signs of pest, disease or fungal attack present at this time.
