# ARBORICULTURAL REPORT

## TREE INSPECTION, RISK ASSESMENT & IMPACT ASSESSMENT

**SITE ADDRESS:** 109 PALMERSTON ST / ROBERTSON PARK, PERTH, WA.

**REPORT DATE:** 01.11.2020

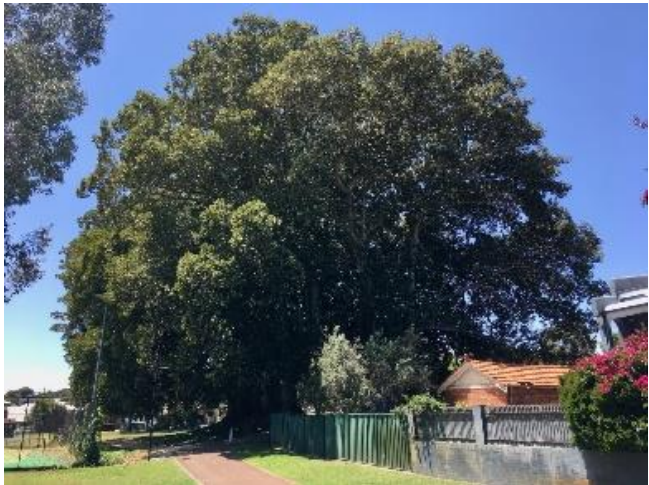
Tree number:	1
Tree location:	Robertson Park (east), Adjacent to 109 Palmerston St. Perth.
Date of Tree Inspection/assessment:	30/10/2020
Botanic name: (Common name)	<i>Ficus macrophylla</i> (Moreton Bay Fig)
Origin of species:	Native, Q/NSW
Trunk diameters: DBH, Basal Ø:	3.1m, 3.1m
Height: (approx.)	28m
Crown spread: (N/E/S/W)	15m/21m/10m/22m
Age:	Mature (Veteran)
Health:	Good. No evidence of detrimental levels of pests or diseases, foliage appearance and density good. Inner/lower crown minor deadwood present. Epicormic regrowth on lower stem pruning cuts.
Structure:	Good. Significant above ground buttress root development to (average) 6m from stem. Stem divides at 3.4m agl- union appears sound. Significant hollow at base of southern stem at approx. 4m agl, from apparent stem failure in past, well occluded, extent of hollow not observed. Stem/branch structural unions in upper crown appear sound. Stem/buttress fluting displaying reaction wood indicating good response to external stresses. No evidence of root plate lift or recent major limb failure

Crown form:	Co-dominant, broad, asymmetrical.
Useful life expectancy:	> 25 years
Maintenance recommendations:	None
Additional observations:	Recent extensive canopy reduction pruning to south over subject property
QTRA Risk rating - whole (WT) part tree (PT) failure within following 12-month period:	PT - T3, S2, PoF 6 = RoH: 1/<1M -Broadly Acceptable. WT- T3, S1, PoF 6 = RoH: 1/<1M -Broadly Acceptable.
Image of subject tree: (From South)

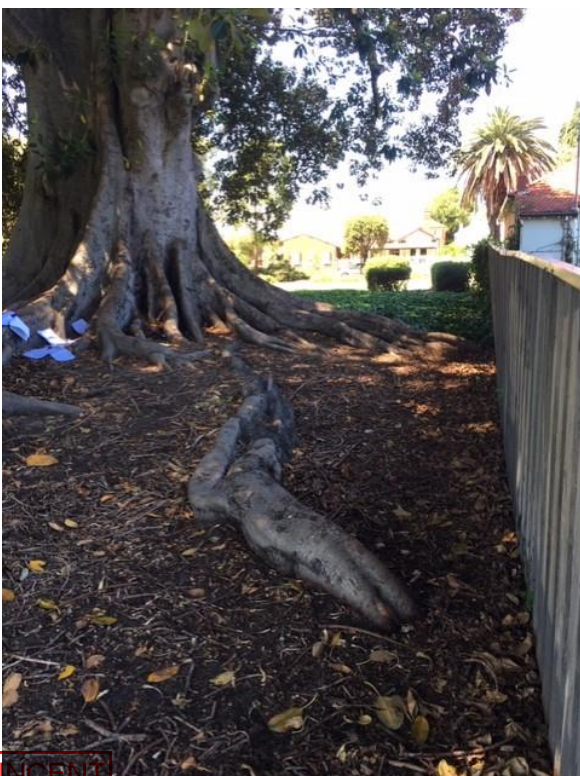
7.3 Buttress roots and subject property boundary:

**9.2** No exposed buttress or structural roots were within the subject property boundary.

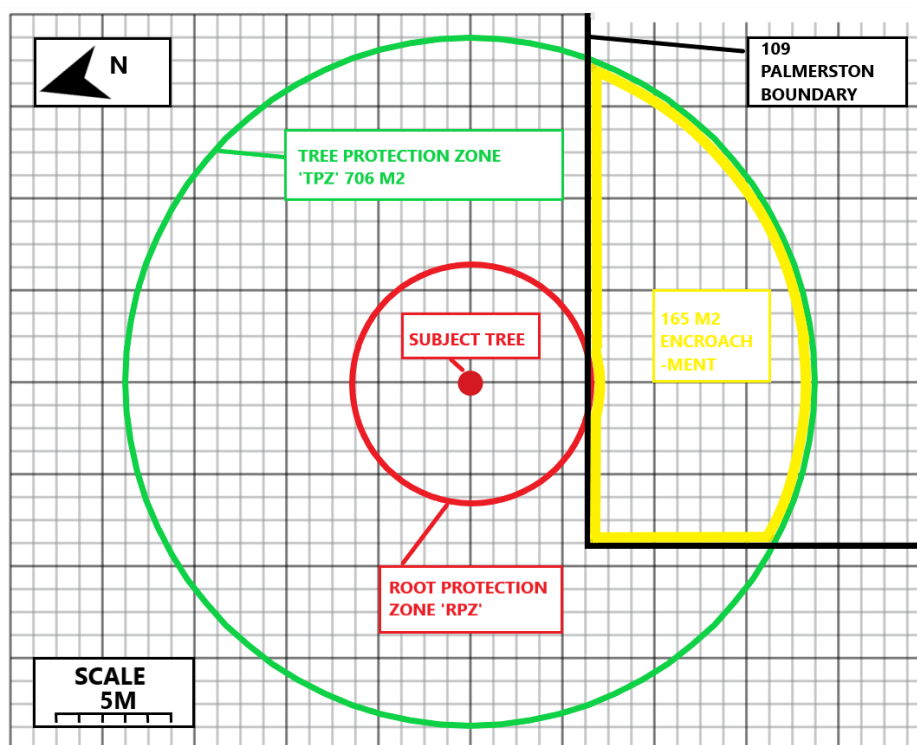
**10.9** Graphic showing approximate scaled location of TPZ/SRZ dimensions, and areas of encroachment of the site, should the entire site be demolished, sifted, graded and compacted prior to development. Encroachment into the SRZ is negligible, however TPZ encroachment is approximately 23 %.

**10.10** Given that the subject tree is able to extend and develop roots in areas of the park contiguous with the TPZ, the percentage of encroachment in most cases would be acceptable, however as noted above, the subject tree being almost beyond maturity, construction activities in this area should be carried out with minimal disturbance to the tree.

**10.6** Protective fencing at a minimum distance of two metres from the base of the tree generally provides sufficient protection for structural roots in most cases, and prevents damage to the main stem and assists in making contractors aware of the need for caution when working near trees.

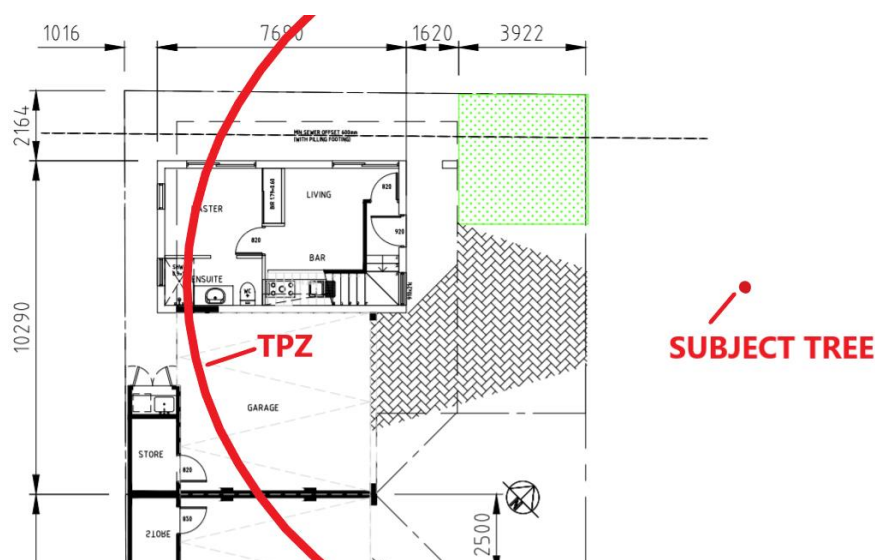
**11.3** Below is a thumbnail sketch (scale approximate) providing an estimate of TPZ encroachment from the finished development:

**11.5** In the above image, the percentage of encroachment from the finished development is likely to be minor (Note. finalised plans with dimensions will be required to determine exact extent of encroachment) and the following construction methods should be utilised within the TPZ to reduce impact: Note. The following recommendations may require amendment upon finalisation of plans.

- Pier and beam type boundary fencing will be required to avoid transverse trenching across the root system – pier footings can be manually excavated to leave roots intact. The above ground beams allow for further root expansion without damage to masonry. 'Colourbond' fencing'- without plinths installed - is also suitable.

- Drive way paving should be manually compacted (ie. with small plate compactor to avoid root damage prior to paving, without the use of exterior grout to allow for penetration of water and nutrients. Note. permeable paving with a 'no fines' substrate laid onto geotextile is preferred to better allow for precipitation to reach subject tree roots and limit future lifting of paving from opportunistic root development.
