# ARBORICULTURAL REPORT

## TREE INSPECTION, RISK ASSESMENT & IMPACT ASSESSMENT

**SITE ADDRESS:** 109 PALMERSTON ST / ROBERTSON PARK, PERTH, WA.

**REPORT DATE:** 01.11.2020

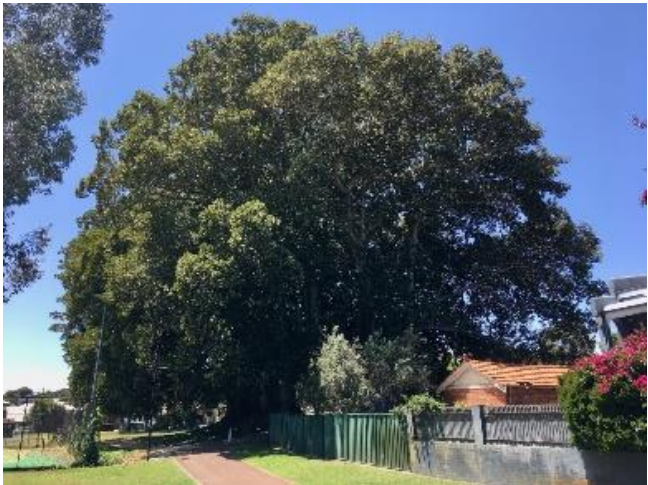
| Health: | Good. No evidence of detrimental levels of pests or diseases, foliage appearance and density good. Inner/lower crown minor deadwood present. Epicormic regrowth on lower stem pruning cuts. |
| Structure: | Good. Significant above ground buttress root development to (average) 6m from stem. Stem divides at 3.4m agl- union appears sound. Significant hollow at base of southern stem at approx. 4m agl, from apparent stem failure in past, well occluded, extent of hollow not observed. Stem/branch structural unions in upper crown appear sound. Stem/buttress fluting displaying reaction wood indicating good response to external stresses. No evidence of root plate lift or recent major limb failure |
| QTRA Risk rating - whole (WT) part tree (PT) failure within following 12-month period: | PT - T3, S2, PoF 6 = RoH: 1/<1M -Broadly Acceptable.<br>WT- T3, S1, PoF 6 = RoH: 1/<1M -Broadly Acceptable. |

| Maintenance recommendations: | None |
