**59 Ellesmere Street, Mount Hawthorn Visual Tree Assessment (VTA) –  
October 2022**

*Visual Tree Assessment (VTA)*  
*1x Jacaranda mimosifolia*

Reference number: Q005734

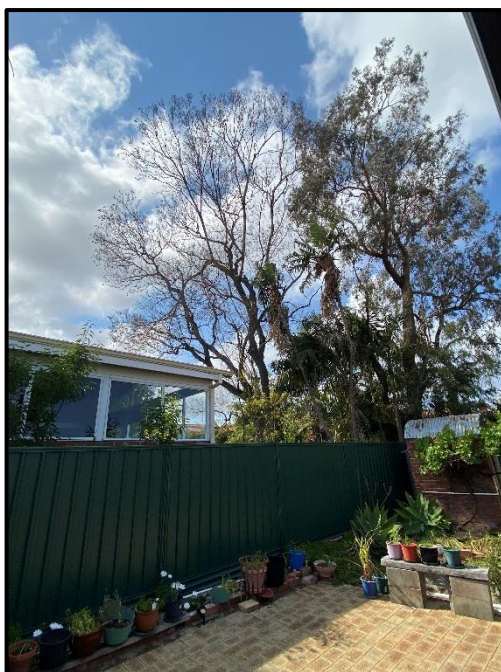
**Figure 2** – Subject tree at the time of inspection (20 October 2022) Image looking South

The subject tree – *Jacaranda mimosifolia* (Jacaranda) was assessed on the 20<sup>th</sup> of October 2022. Minor structural defects were noted within the canopy; however, these flaws/defects are considered to be manageable given the appropriate arboricultural practises are applied moving forward - refer figures 2, 3 & 4 for detail.

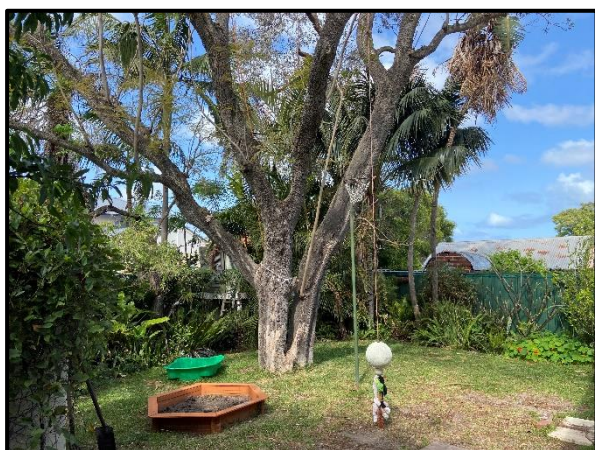
**Figure 3** – Subject tree at the time of inspection (20 October 2022) Image looking South-West

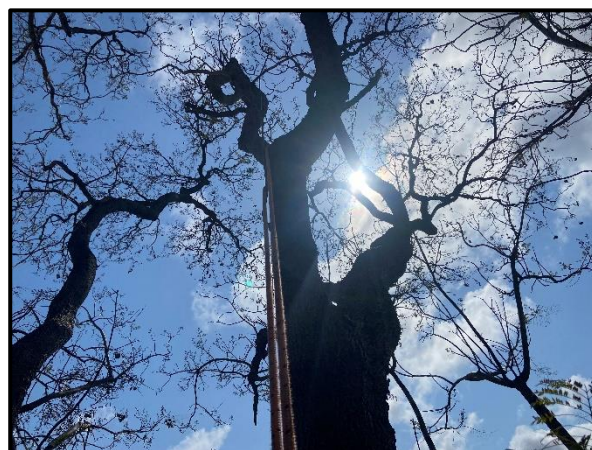
**Figure 4** – Subject tree at the time of inspection (20 October 2022) Image taken during the aerial inspection

- Tree presents a unique form; the excessive fluting is not a typical characteristic of Jacaranda's. The fluting appears to be in response to previous damage, however, the tree has stabilised well since the damage and still presents solid wood throughout the canopy.
- Inspection of the root flare and first order roots revealed no apparent soil cracks, root plate subsidence, heaving, or noticeable movement at ground level, with good root taper and minor fill noted to the North, East and West sides of the tree (<100mm) however is not considered as a concern at this time.

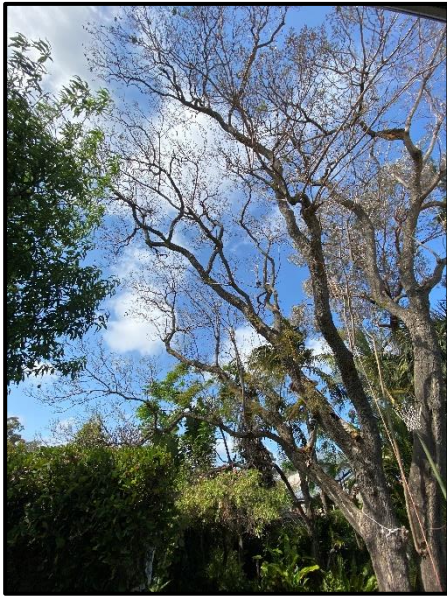
*Image taken by Arbor Centre facing South – showing canopy heading toward eastern neighbour*

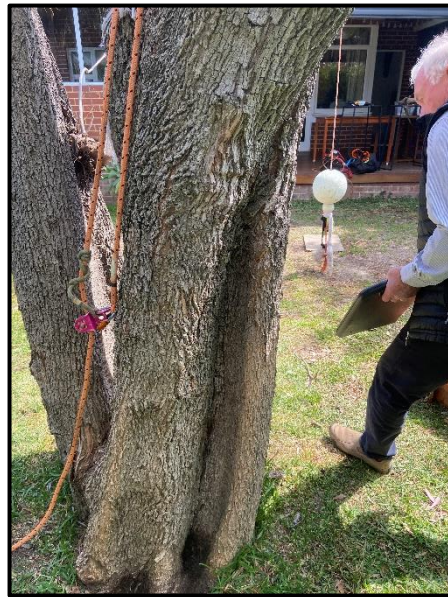
*Image taken by Arbor Centre facing North – showing fluting at ground level*

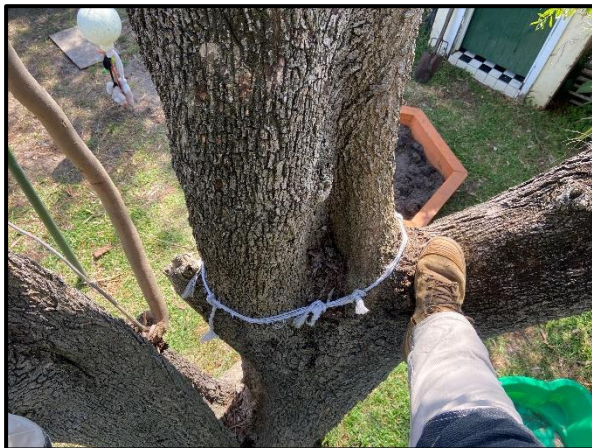
*Image taken by Arbor Centre from within canopy – showing fluting within the canopy*

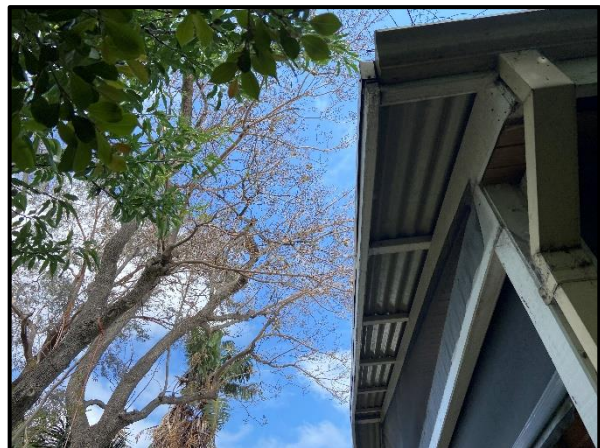
Several structural issues were observed including; previous deleterious pruning (i.e. tree has been lion tailed, however canopy structure could be remediated to offset previous works); stem failures ranging from 50 mm dia. to 150 mm in diameter; deadwood ranging to 50 mm in diameter, minor rubbing and crossing stems to 50mm, however; these issues are generally considered manageable within the scope of an ongoing, proactive tree management, canopy pruning and monitoring program.

*Image taken by Arbor Centre facing West – showing failed stem caught in canopy*

- That Corrective/Remedial Canopy Pruning be undertaken to address structural defects that were noted in the inspection;
- Aerially inspect the remainder of the canopy for potential structural, health and/or other issues that may not be detectable from ground level.

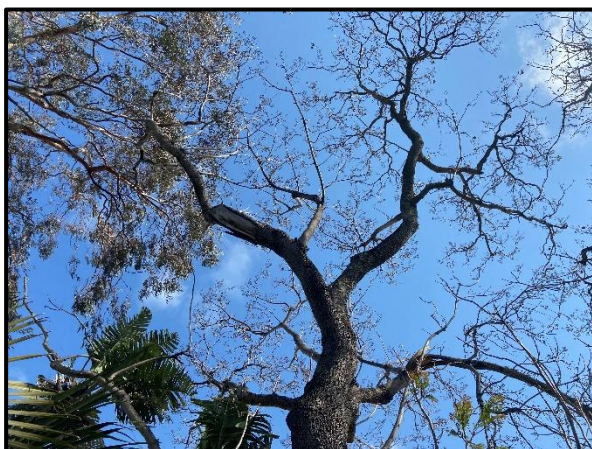
*Image taken by Arbor Centre from within canopy – showing wounding from previous failures*

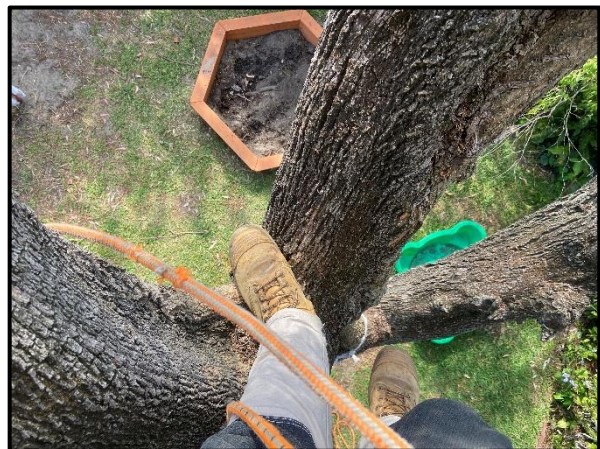
*Image taken by Arbor Centre from within canopy – showing sound unions*
