CONSERVATION PLAN
REDEMPTORIST MONASTERY AND CHURCH
NORTH PERTH
JUNE 2011

Job Number 10154

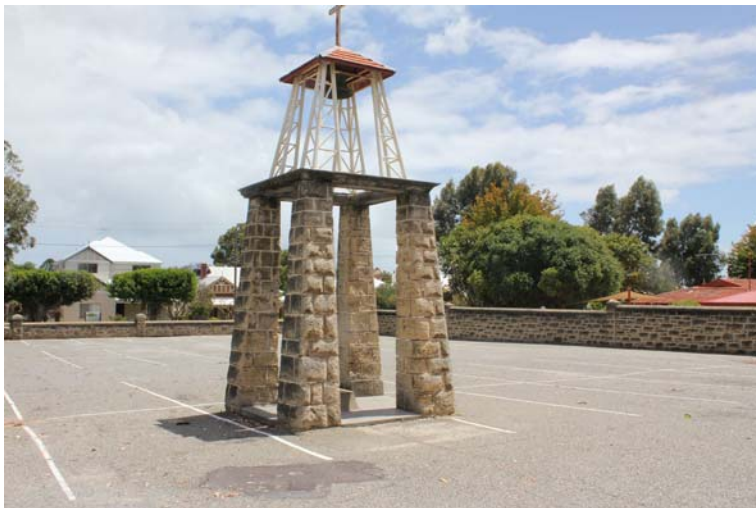
Photograph 53

View of the car park and belfry to the west of the church. The belfry is now in poor condition.

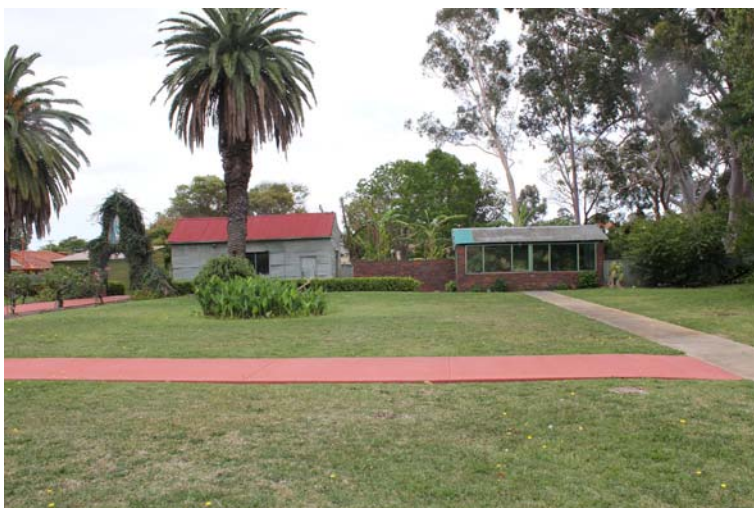
Photograph 57

View of the greenhouse (right), corrugated iron sheds (centre-left) and grotto (left) located to the north of the formal garden. These sheds are all in poor condition.

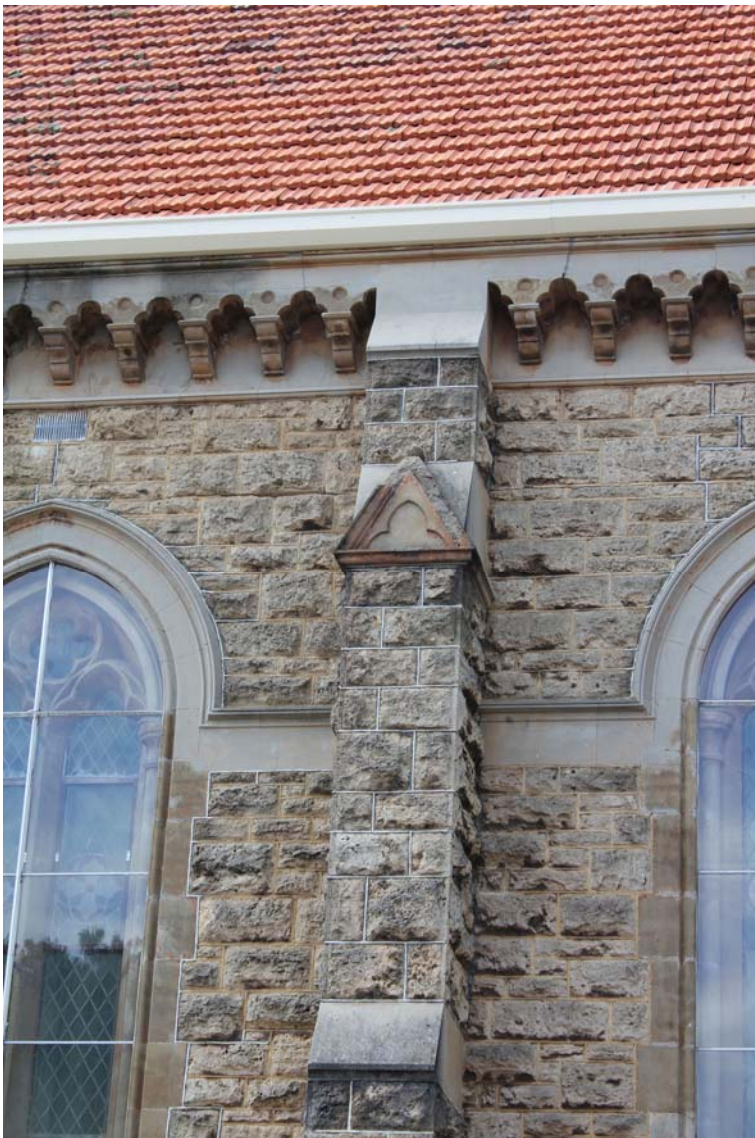
Photograph 75

Detail of the west elevation showing ornate dentils. The gutter replaces the original ogee profile gutters. Note the addition of protective screens to the leadlights.

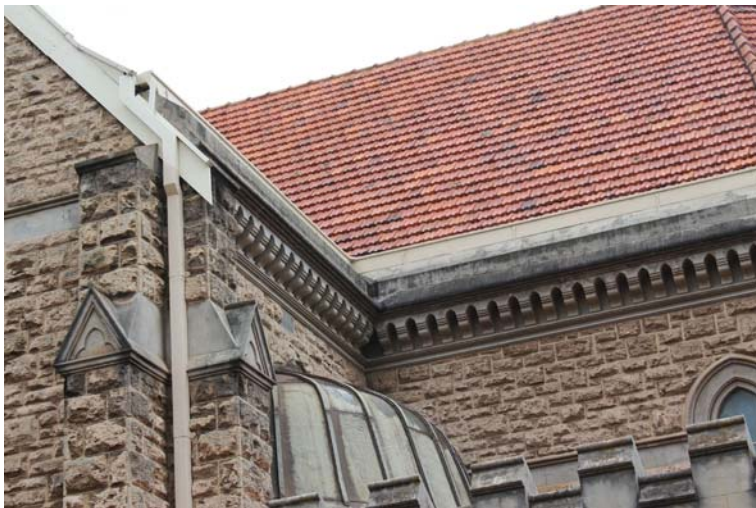
Photograph 77

Photograph showing the modified guttering to the sanctuary. The chapels have copper roofs, but the lack of gutters has caused some falling damp issues.

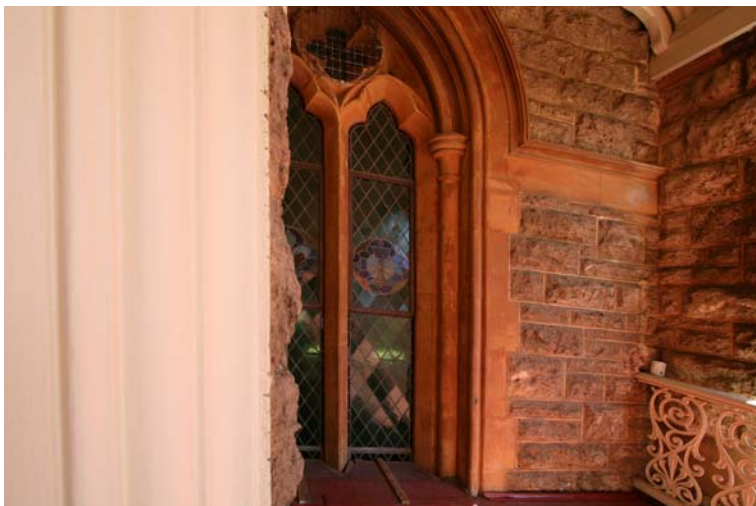
Photograph 78

View of the east wall of the church adjacent to the northern verandah, where the original staining to the stucco work has been protected.
