# **ARBORICULTURAL REPORT**

# TREE INSPECTION, RISK ASSESMENT & IMPACT ASSESSMENT

**SITE ADDRESS**: 109 PALMERSTON ST / ROBERTSON PARK, PERTH, WA.

**REPORT DATE:** 01.11.2020

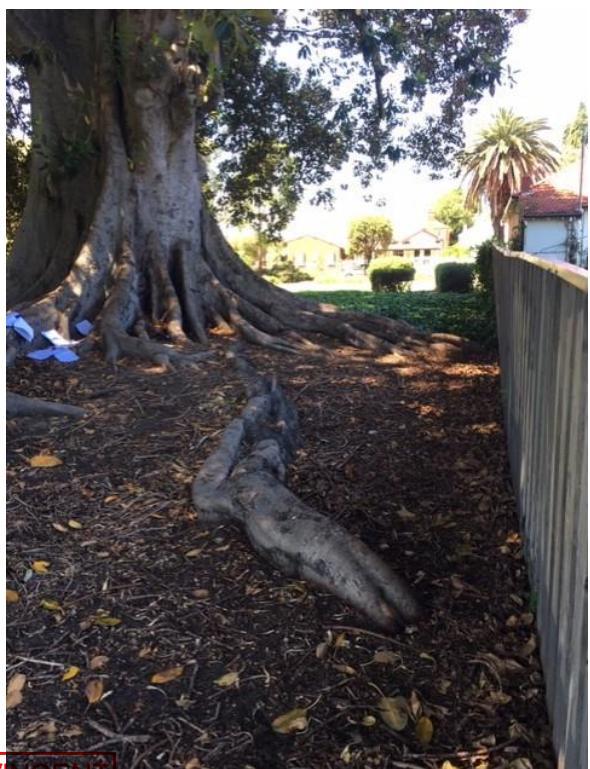
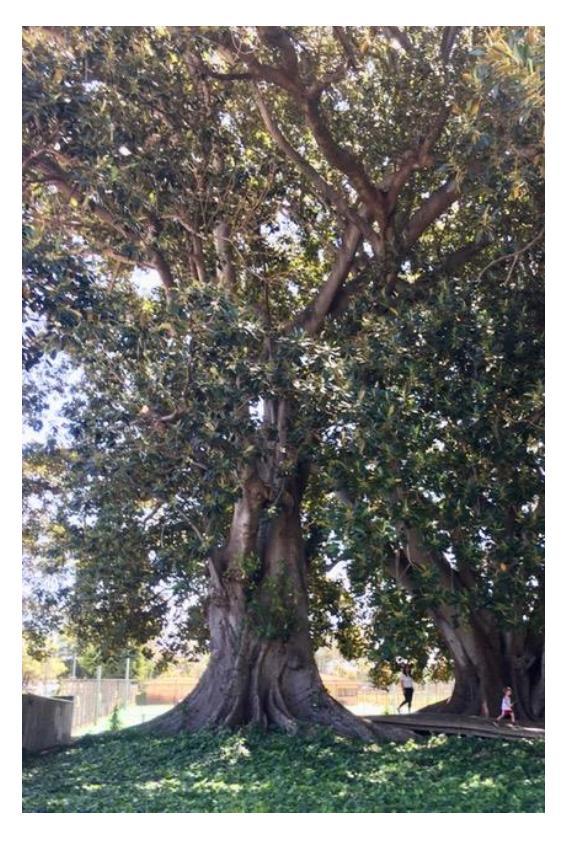
7.4 Stem and branch structure:

structural unions in upper crown appear sound.				
	Stem/buttress fluting displaying reaction wood				
	indicating good response to external stresses. No				
	evidence of root plate lift or recent major limb failure				
Crown form:	Co-dominant, broad, asymmetrical.				
Useful life expectancy:	> 25 years				
Maintenance recommendations:	None				
Additional observations:	Recent extensive canopy reduction pruning to south				
	over subject property				
QTRA Risk rating - whole (WT) part tree (PT)	PT - T3, S2, PoF 6 = RoH: 1/<1M -Broadly Acceptable.				
failure within following 12-month period:	WT- T3, S1, PoF 6 = RoH: 1/<1M -Broadly Acceptable.				
Image of subject tree: (From South)

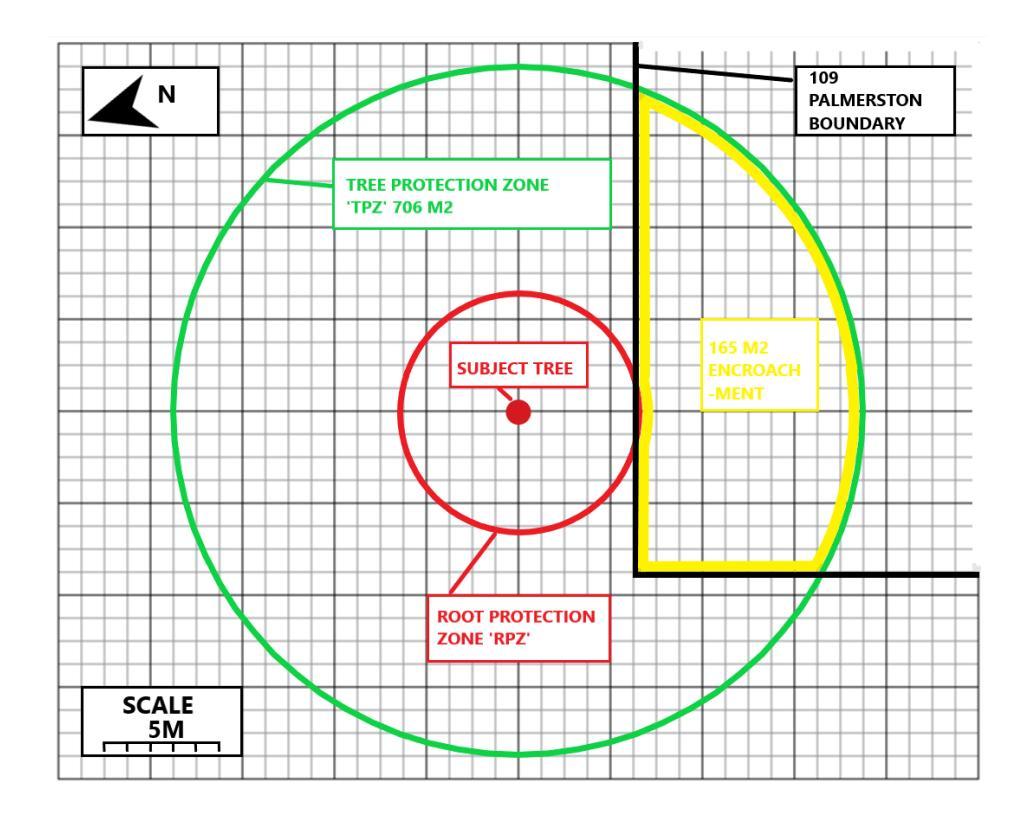
**10.9** Graphic showing approximate scaled location of TPZ/SRZ dimensions, and areas of encroachment of the site, should the entire site be demolished, sifted, graded and compacted prior to development. Encroachment into the SRZ is negligible, however TPZ encroachment is approximately 23 %.

**10.10** Given that the subject tree is able to extend and develop roots in areas of the park contiguous with the TPZ, the percentage of encroachment in most cases would be acceptable, however as noted above, the subject tree being almost beyond maturity, construction activities in this area should be carried out with minimal disturbance to the tree.

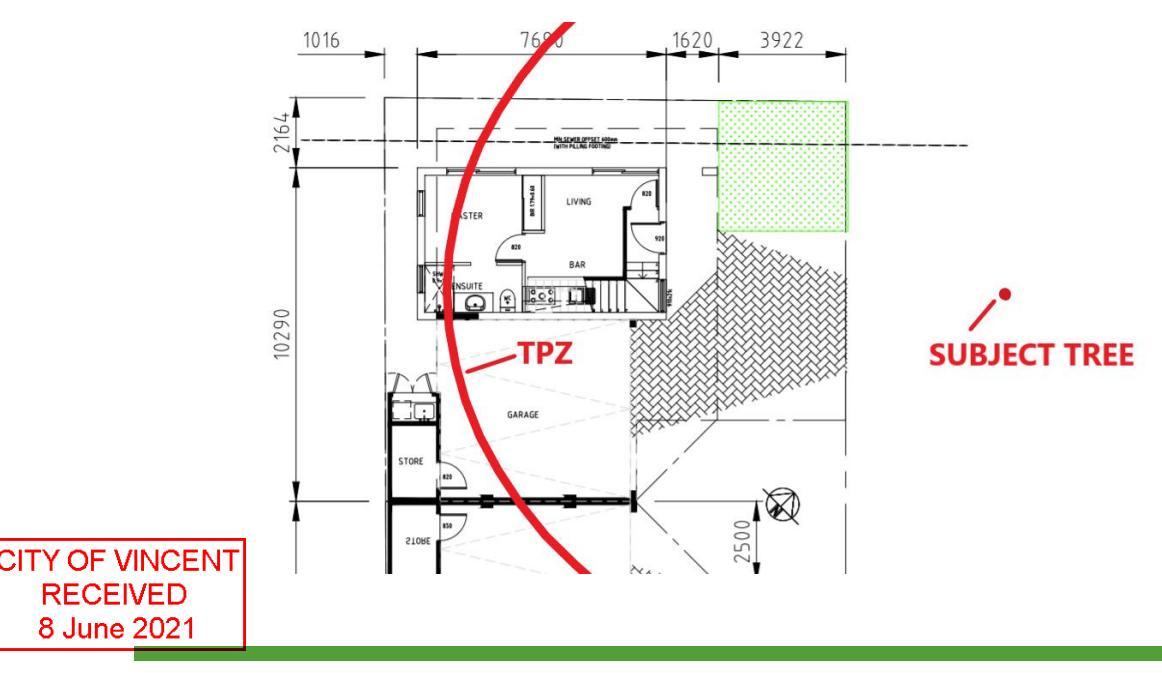
**11.3** Below is a thumbnail sketch (scale approximate) providing an estimate of TPZ encroachment from the finished development:

**11.5** In the above image, the percentage of encroachment from the finished development is likely to be minor (Note. finalised plans with dimensions will be required to determine exact extent of encroachment) and the following construction methods should be utilised within the TPZ to reduce impact: Note. The following recommendations may require amendment upon finalisation of plans.

- For the duration of demolition and site grading operations, the TPZ should be fenced off entirely within the subject property to avoid compaction and root severance. Any resulting level discrepancy should be manually carried out.

- Pier and beam type boundary fencing will be required to avoid transverse trenching across the root system – pier footings can be manually excavated to leave roots intact. The above ground beams allow for further root expansion without damage to masonry. 'Colourbond' fencing'-without plinths installed - is also suitable.
