CITY OF VINCENT

Council Briefing

11 September 2018

5 DEVELOPMENT SERVICES**5.4 LATE REPORT: NO. 3 (LOT: 47; D/P: 1177) BULWER AVENUE, PERTH - EXISTING AND PROPOSED ALTERATIONS TO SINGLE HOUSE**

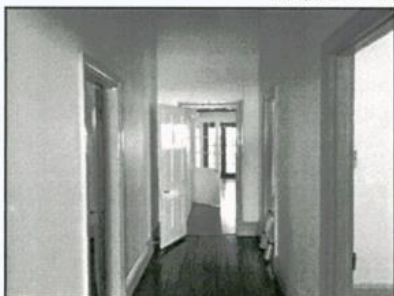
Cosmetic cracking noted

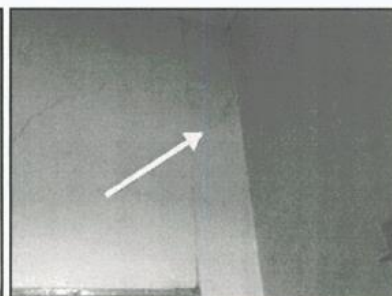
Cosmetic cracking noted

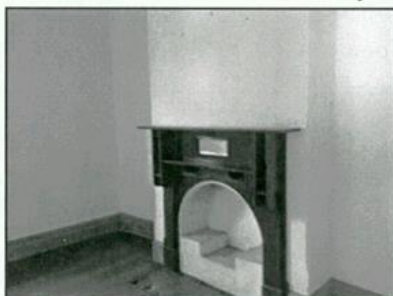
Cosmetic cracking noted

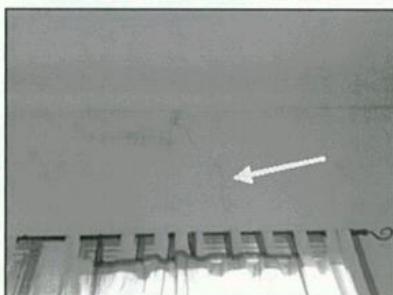
Cosmetic cracking noted

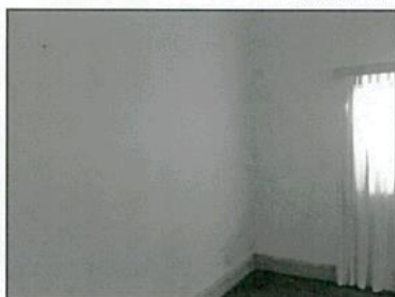
- 1.1. Cosmetic cracking noted, not considered significant, suggest repair to improve appearance.
- 1.2. Evidence of repairs observed, unable to determine the effectiveness of these repairs.
- 1.3. Dry at the time of the inspection.
- 1.4. Significant CRACKS in areas. Recommendations: Contact a licensed Builder or Structural Engineer for further advice and recommendations

Significant cracking noted.

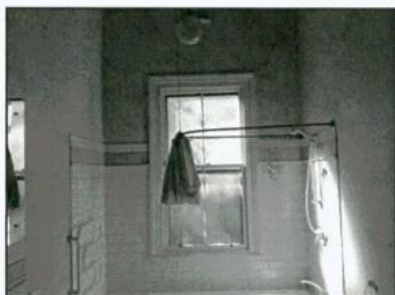
Past moisture damage noted.

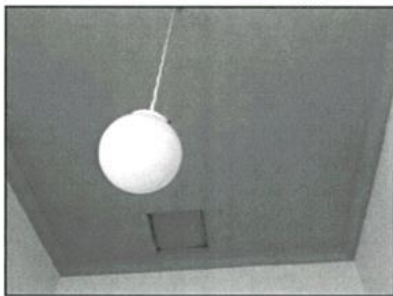
Peeling paint noted.

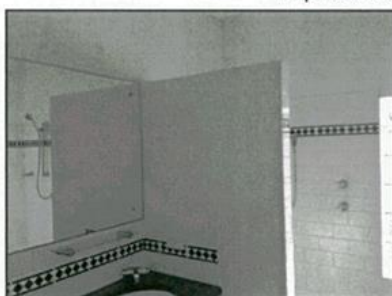
Cosmetic cracking noted

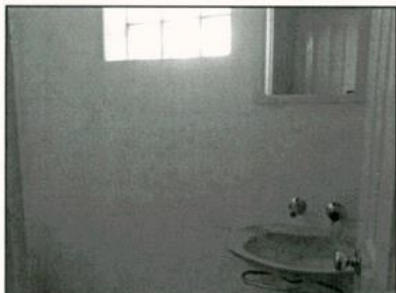
Cosmetic cracking noted

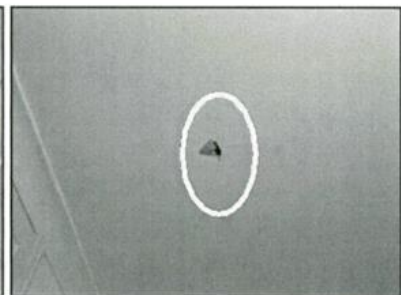
Minor damage noted.

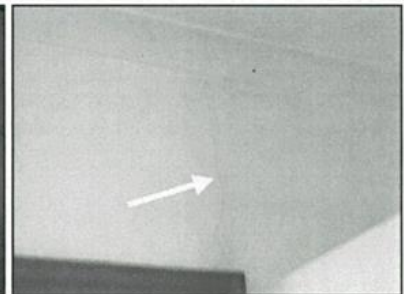
Cosmetic cracking noted

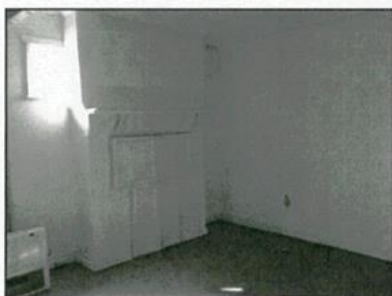
Cosmetic cracking noted

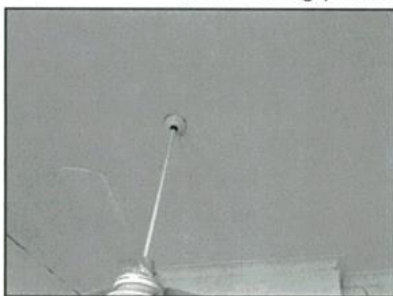
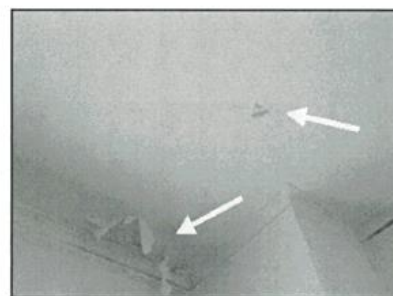
Peeling paint noted.

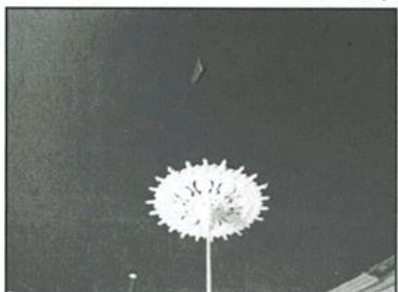
Peeling paint, common cracks noted.

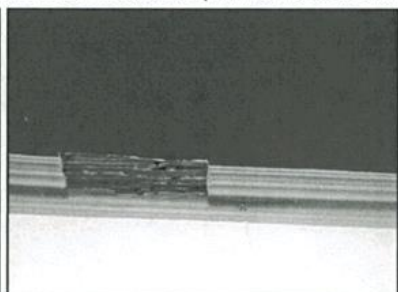
3.3. Significant cracking and damage to the edge of the ceiling noted, have a licensed plasterer review/repair to restore function and safety.

Significant cracking and damage noted.

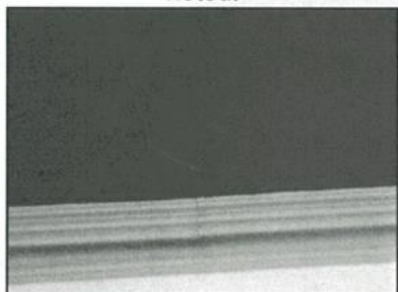
Cracking noted.

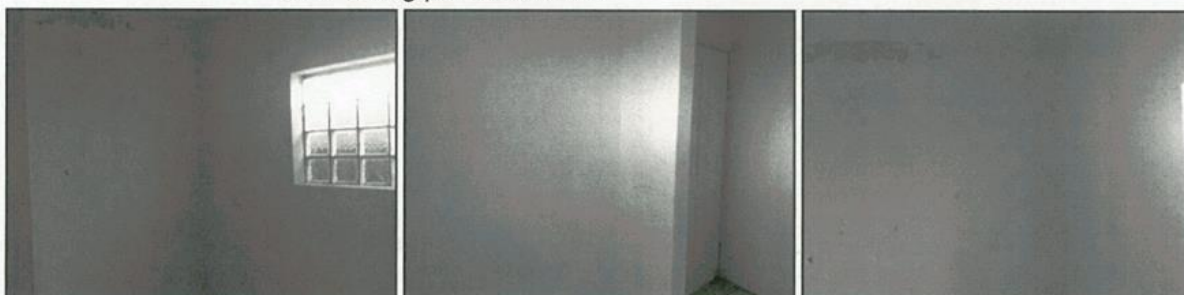
Peeling paint noted.

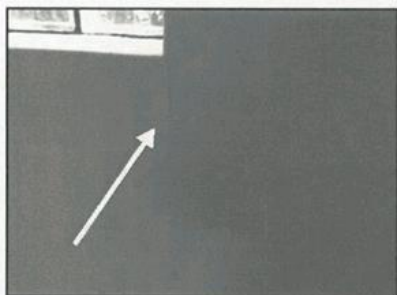
Cosmetic cracking noted

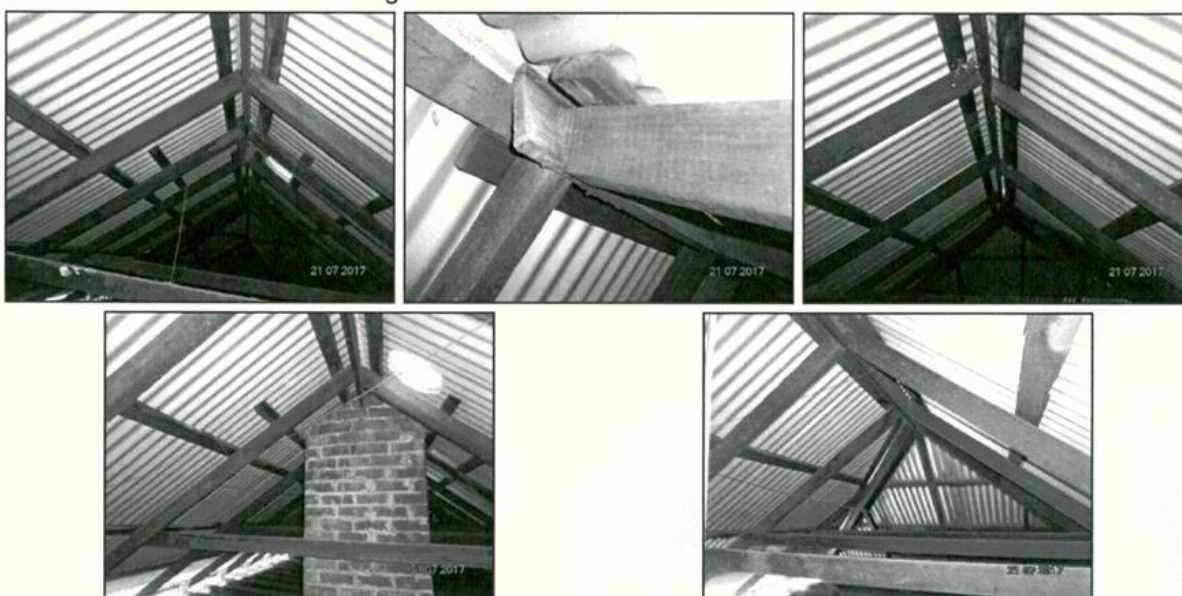
- 2.1. In serviceable condition at the time of inspection
- 2.2. Chemical delignification noted to edge of main board. Recommend monitoring.

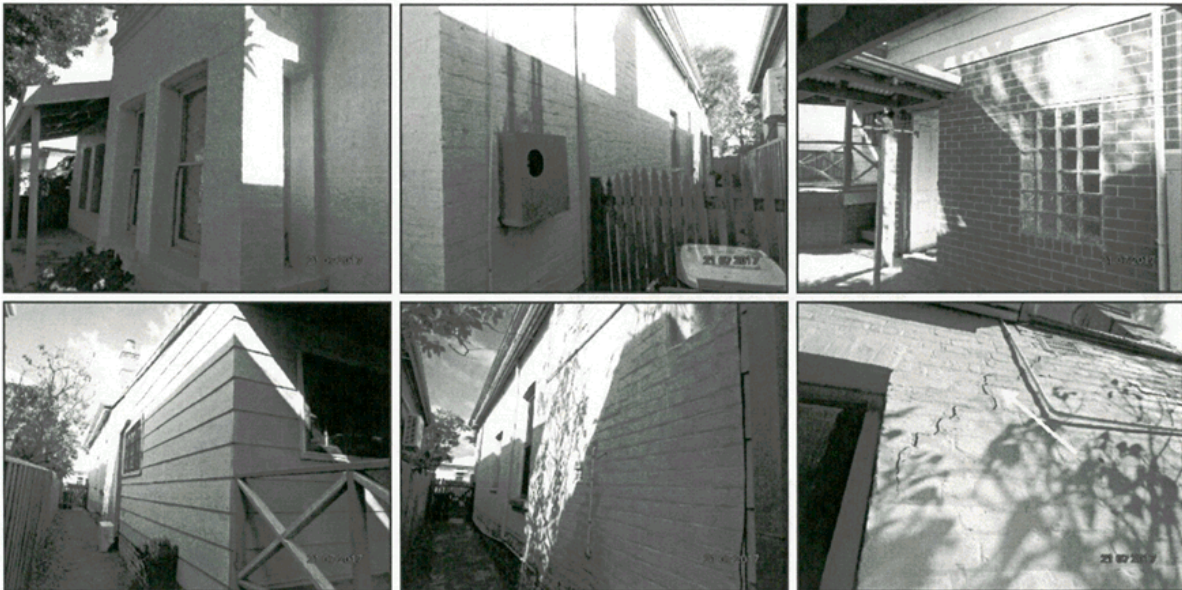
Cracking noted.

1.2. Mortar missing/deteriorated in areas, suggest tuck pointing as necessary.

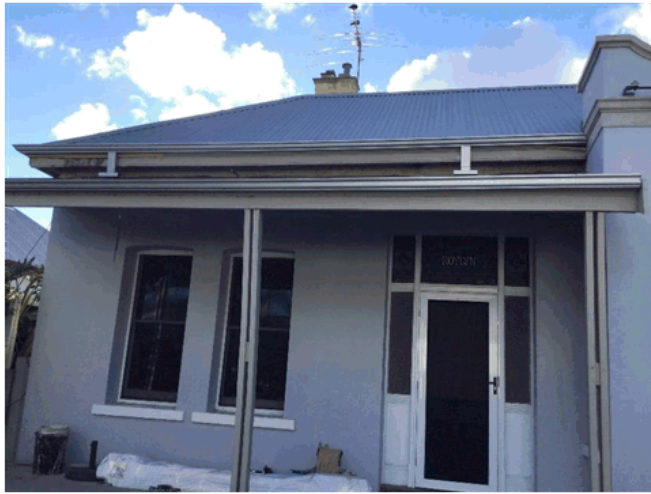
There were no downpipes for this section. Water entered both front rooms. This gutter was replaced with two downpipes installed

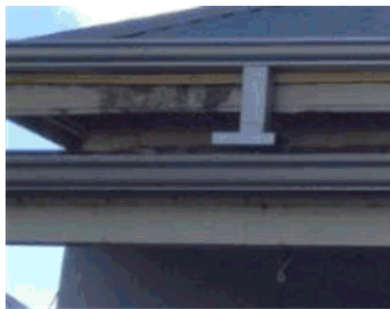
Damage – yet to be repaired. The gutter had fallen and overflowed.

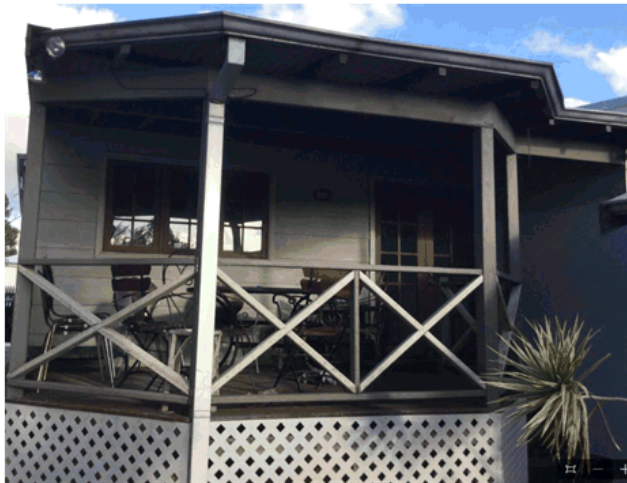
One pipe that cannot and does not meet the run-off demands of 1/3 of the house catchment.

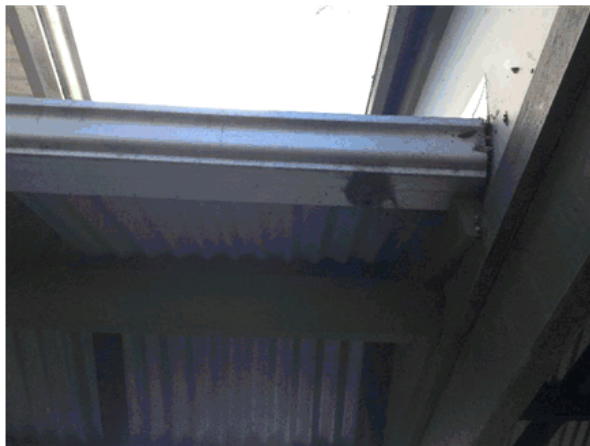
An example of a downpipe yet to be replaced. The previous downpipe... is not there – not this is not an original build but a poorly built renovation.

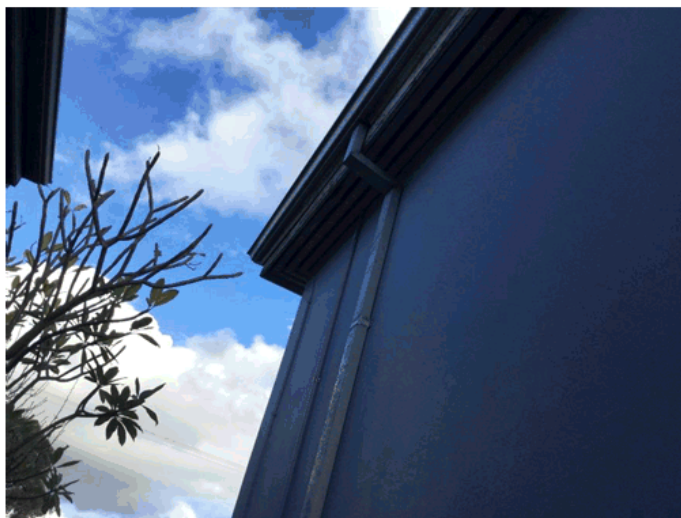
Downpipe was not attached to wall and semi attached to the gutter. This was replaced and attached to the wall. The brickwork where it had been attached did not exist.

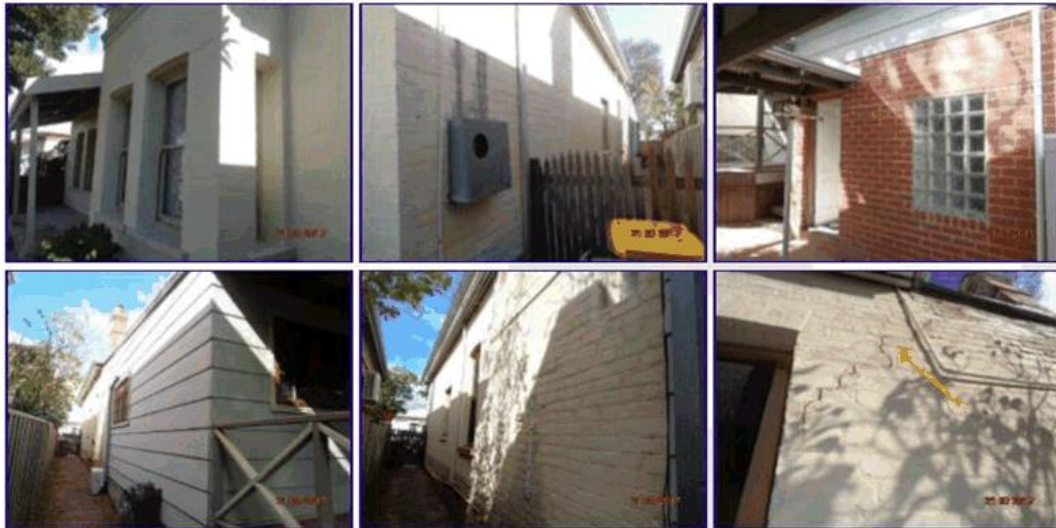
1.1. Moderate cracking evident to brick work or render in areas. Maintenance/Repair may be required, any additional movement should be referred to a Structural Engineer to investigate.

Cracking noted.

1.2. Mortar missing/deteriorated in areas, suggest tuck pointing as necessary.

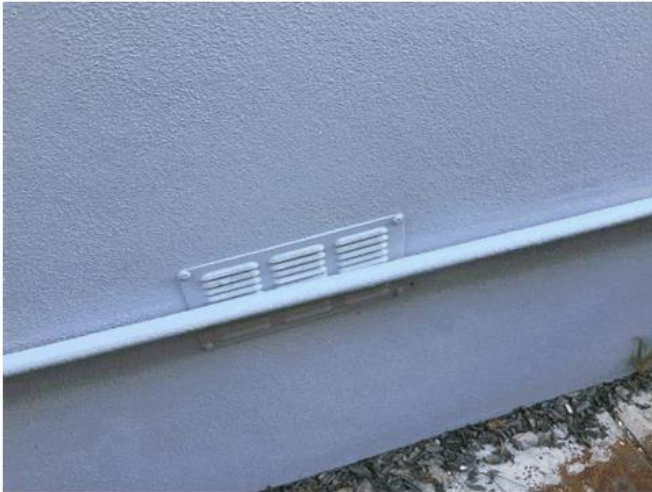
Moisture vents installed – there are six of these in total to remove future water. These did not exist!

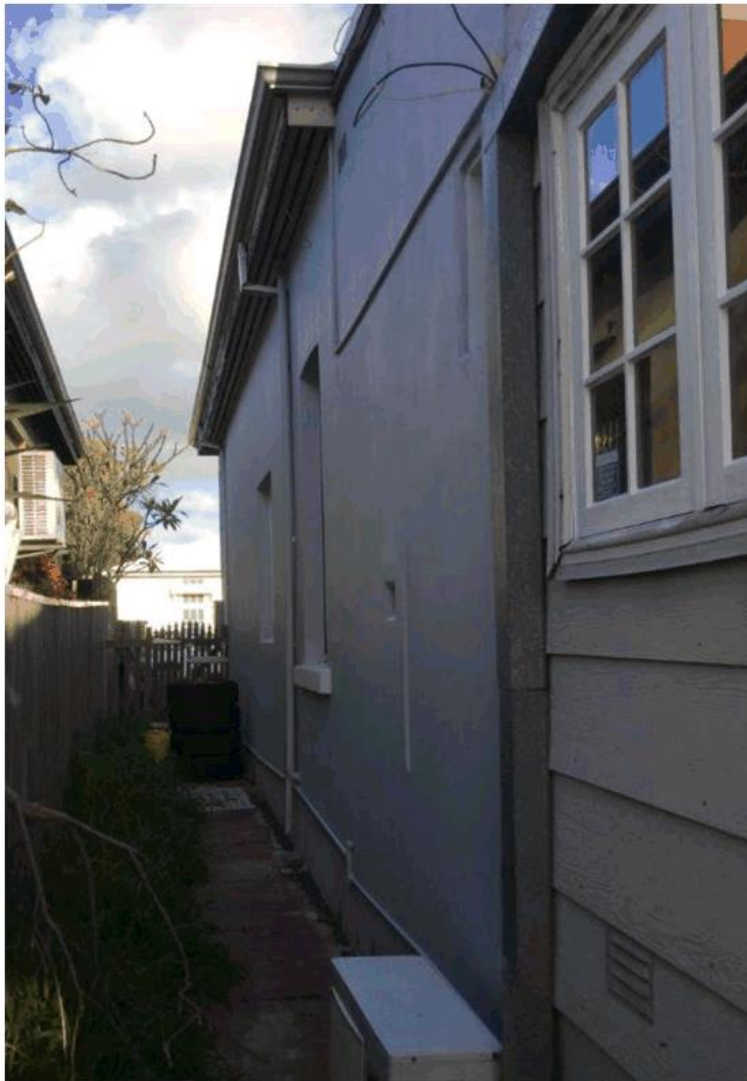
Note the new wall. It is still painted. A different colour that is less offensive to the eye. The cracks and crumbling mortar have been repaired.

The wire and exposed wood – replaced as the old wood was rotten (see below) are yet to be painted and mended due to this stop work order.

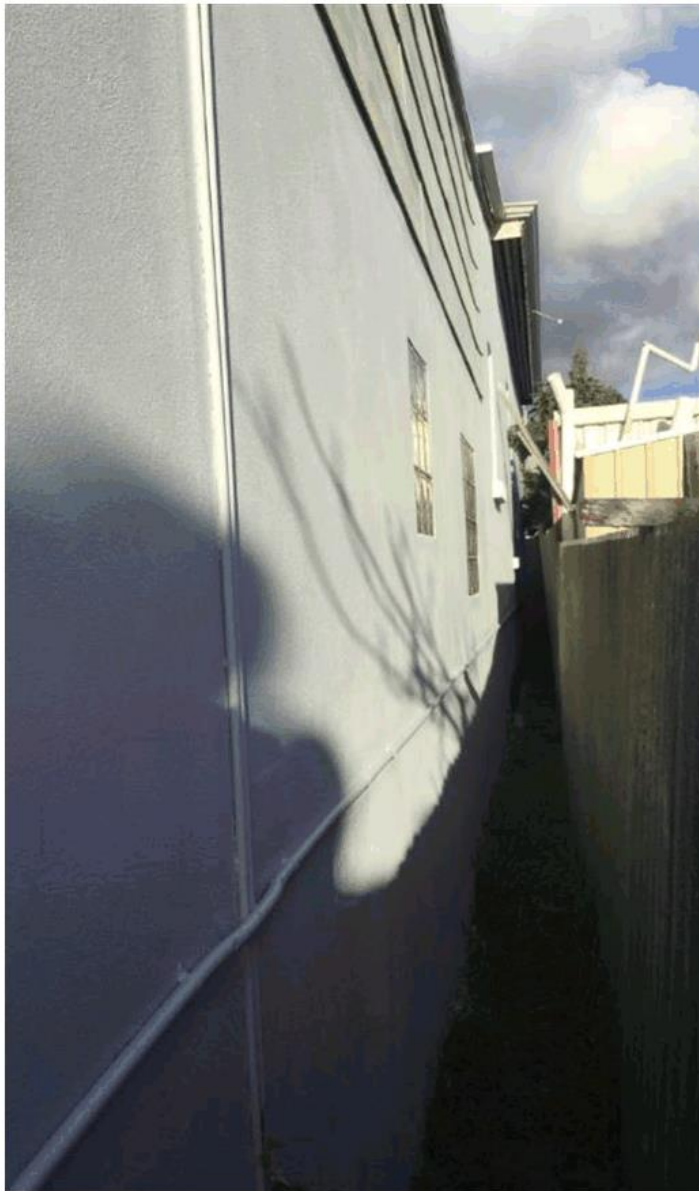
This side of the house had the most damage but cannot be seen. The bedroom window was unsalvageable and was replaced. See picture below.

Cracks etc were replaced. The entry for the pigeons was blocked and sealed.

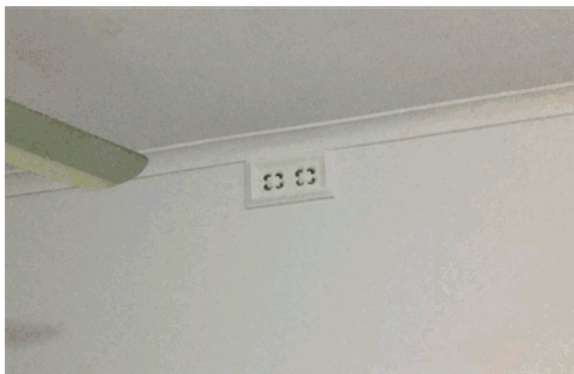
Example of previous roof material used in every other room—they were all previously replaced. Note the new air vent. That was my installation. This reduced water build-up.

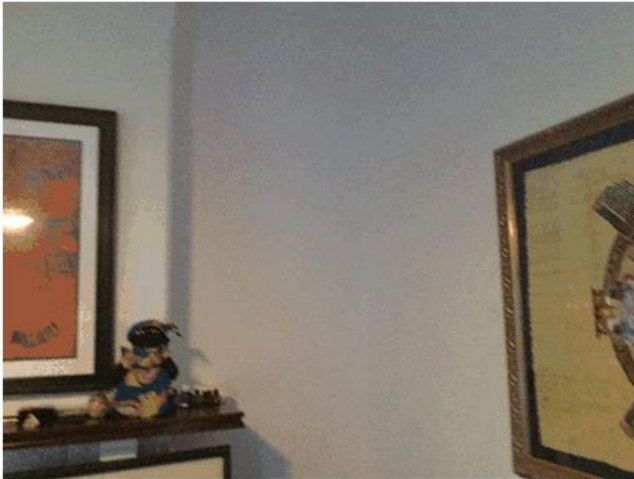
Crack repaired after wall rebraced –
mentioned above.

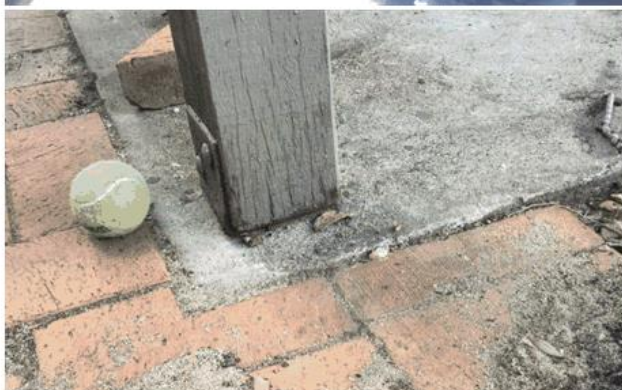
Wood 5mm of ground – one of the five ter nite bridges. Raise. And replace.

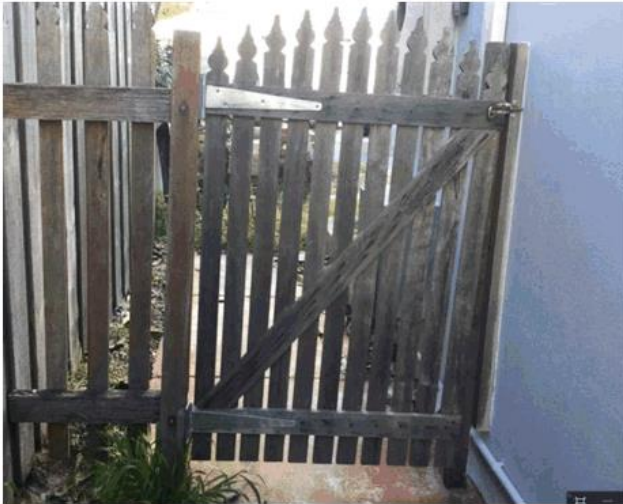
Gate not load strong. It stands up because of the lock. Replace.

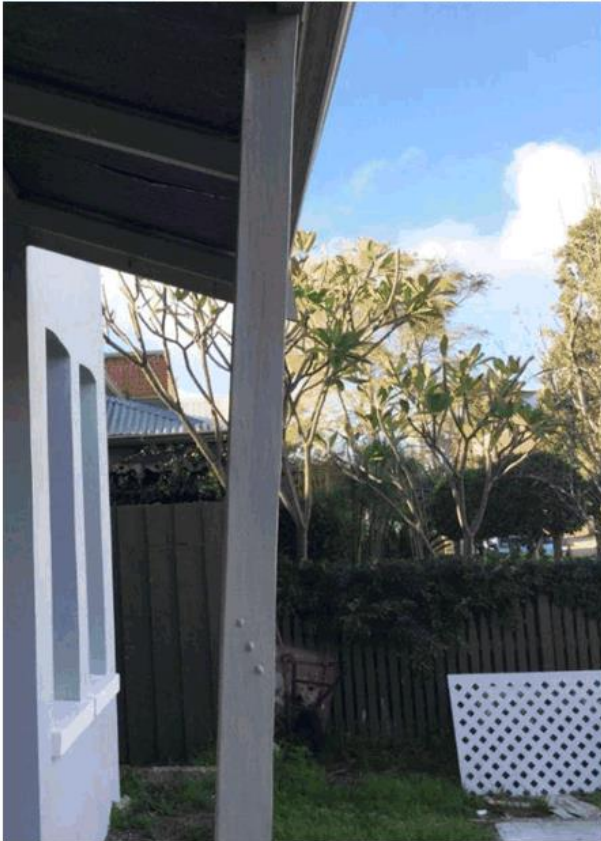
Replace them before the front patio falls down.

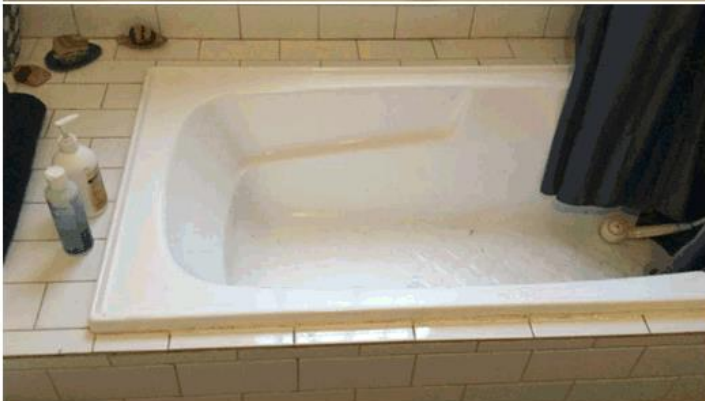
Bath has no floor below it. It cannot hold weight. It is only used as a dog bath. It will need to be replaced.

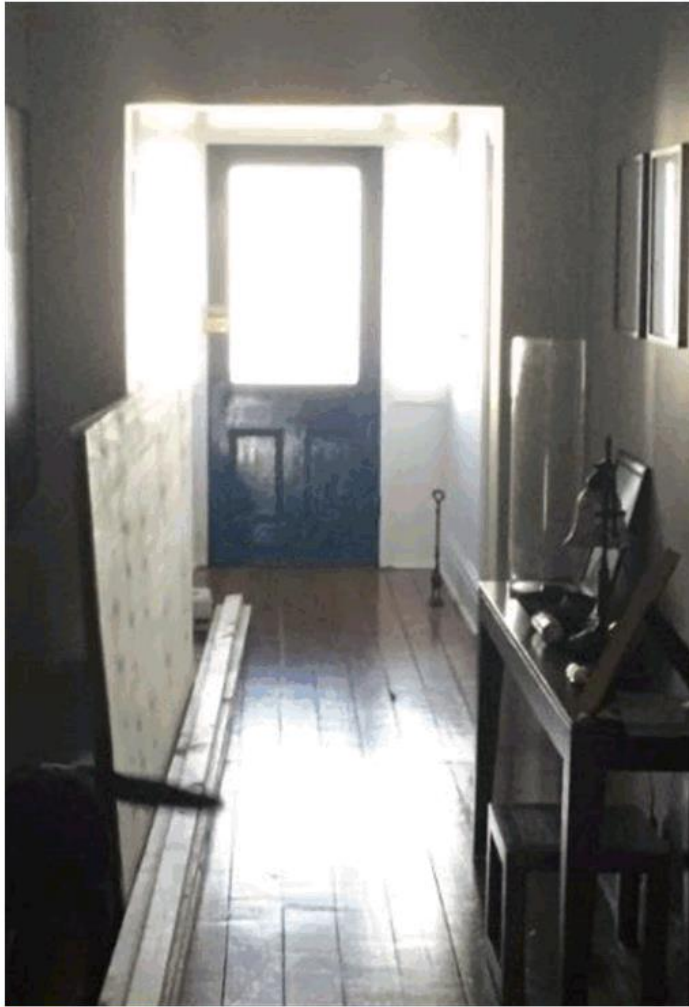
The original arch was built over.

The GVM quote was to re install an arch. This has not been done.

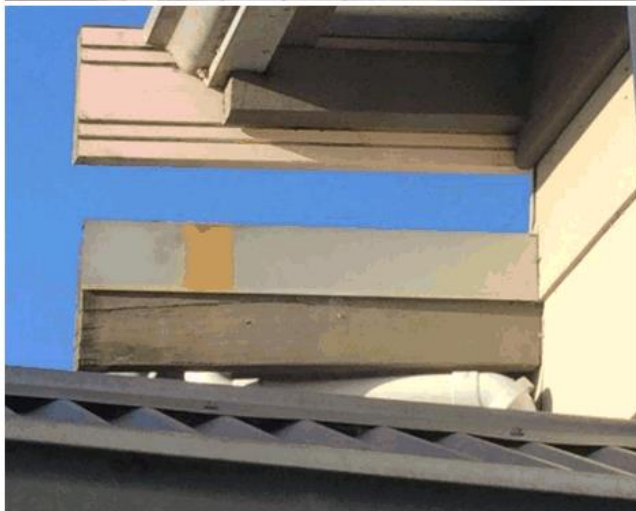
Rotten wood replaced. Still needs painting
