P3138, LOT 254 (40) GUILDFORD RD, MOUNT LAWLEY
Photographic Archival Record

HOCKING HERITAGE + ARCHITECTURE

March 2023

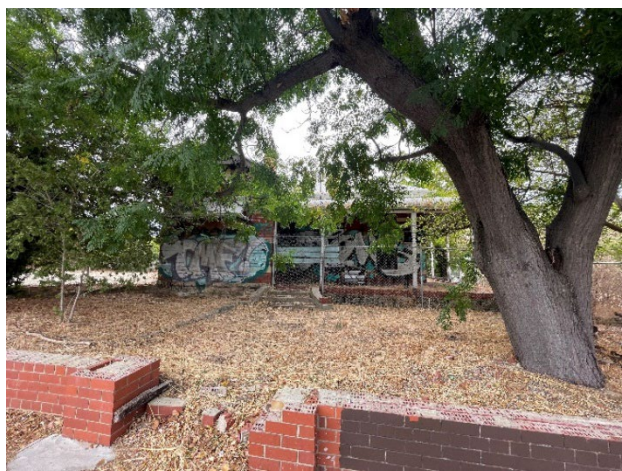
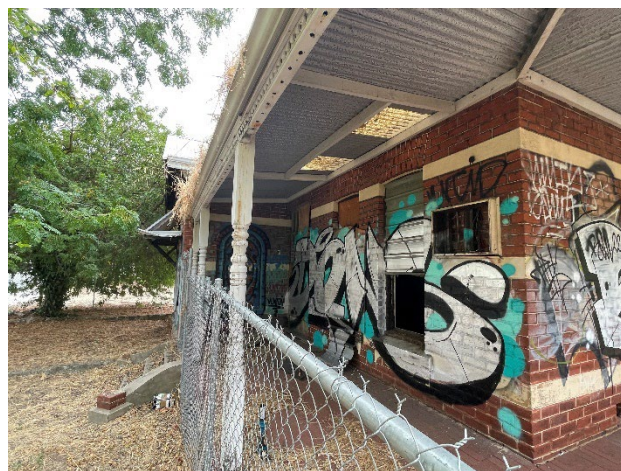
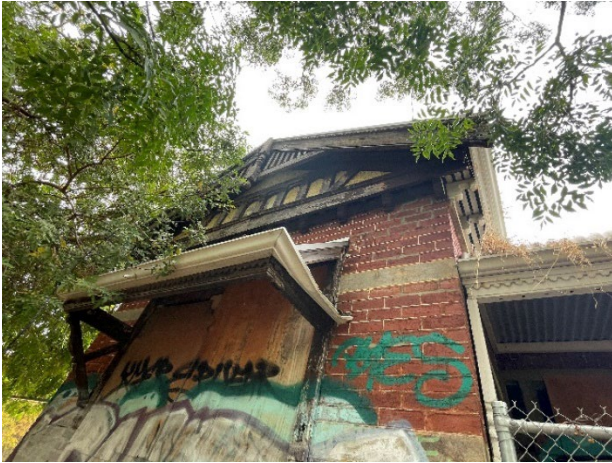
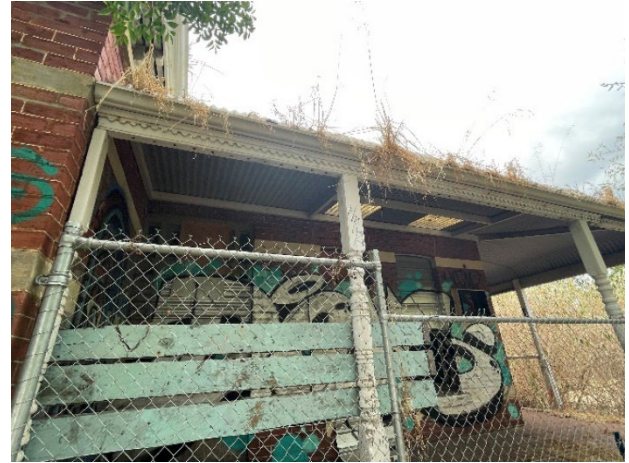
The majority of the exterior of the original residence still demonstrates the brick construction with concrete bands and some remnants of tuckpointing. Large areas of the external walls have graffiti and the surrounding grounds are in poor condition although there are some mature trees.

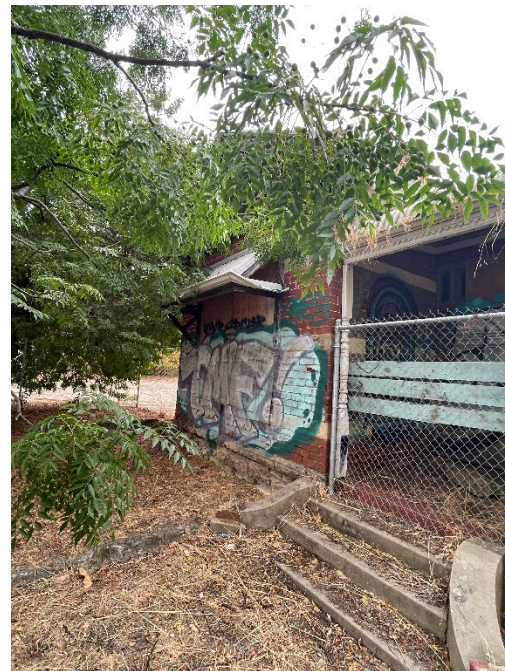
Figure 25: Front Elevation showing original steps.

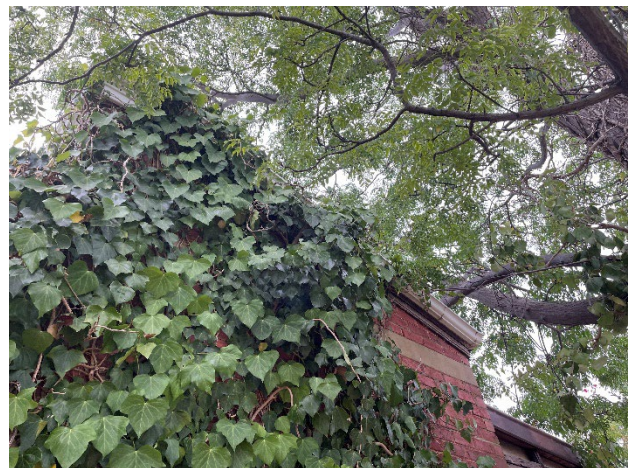
Figure 33: Overgrown creeper on the west elevation.

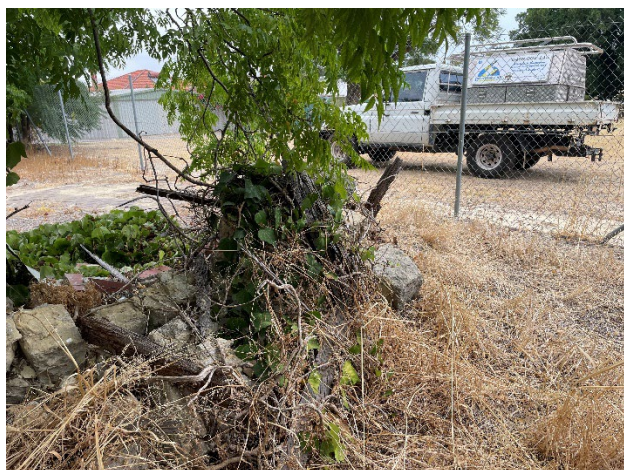
Figure 34: Rubble and degraded plants on the west side of the lot.
