# REFURBISHED SERVICE STATION COMPLEX

41-43 ANGOVE STREET, NORTH PERTH, WA

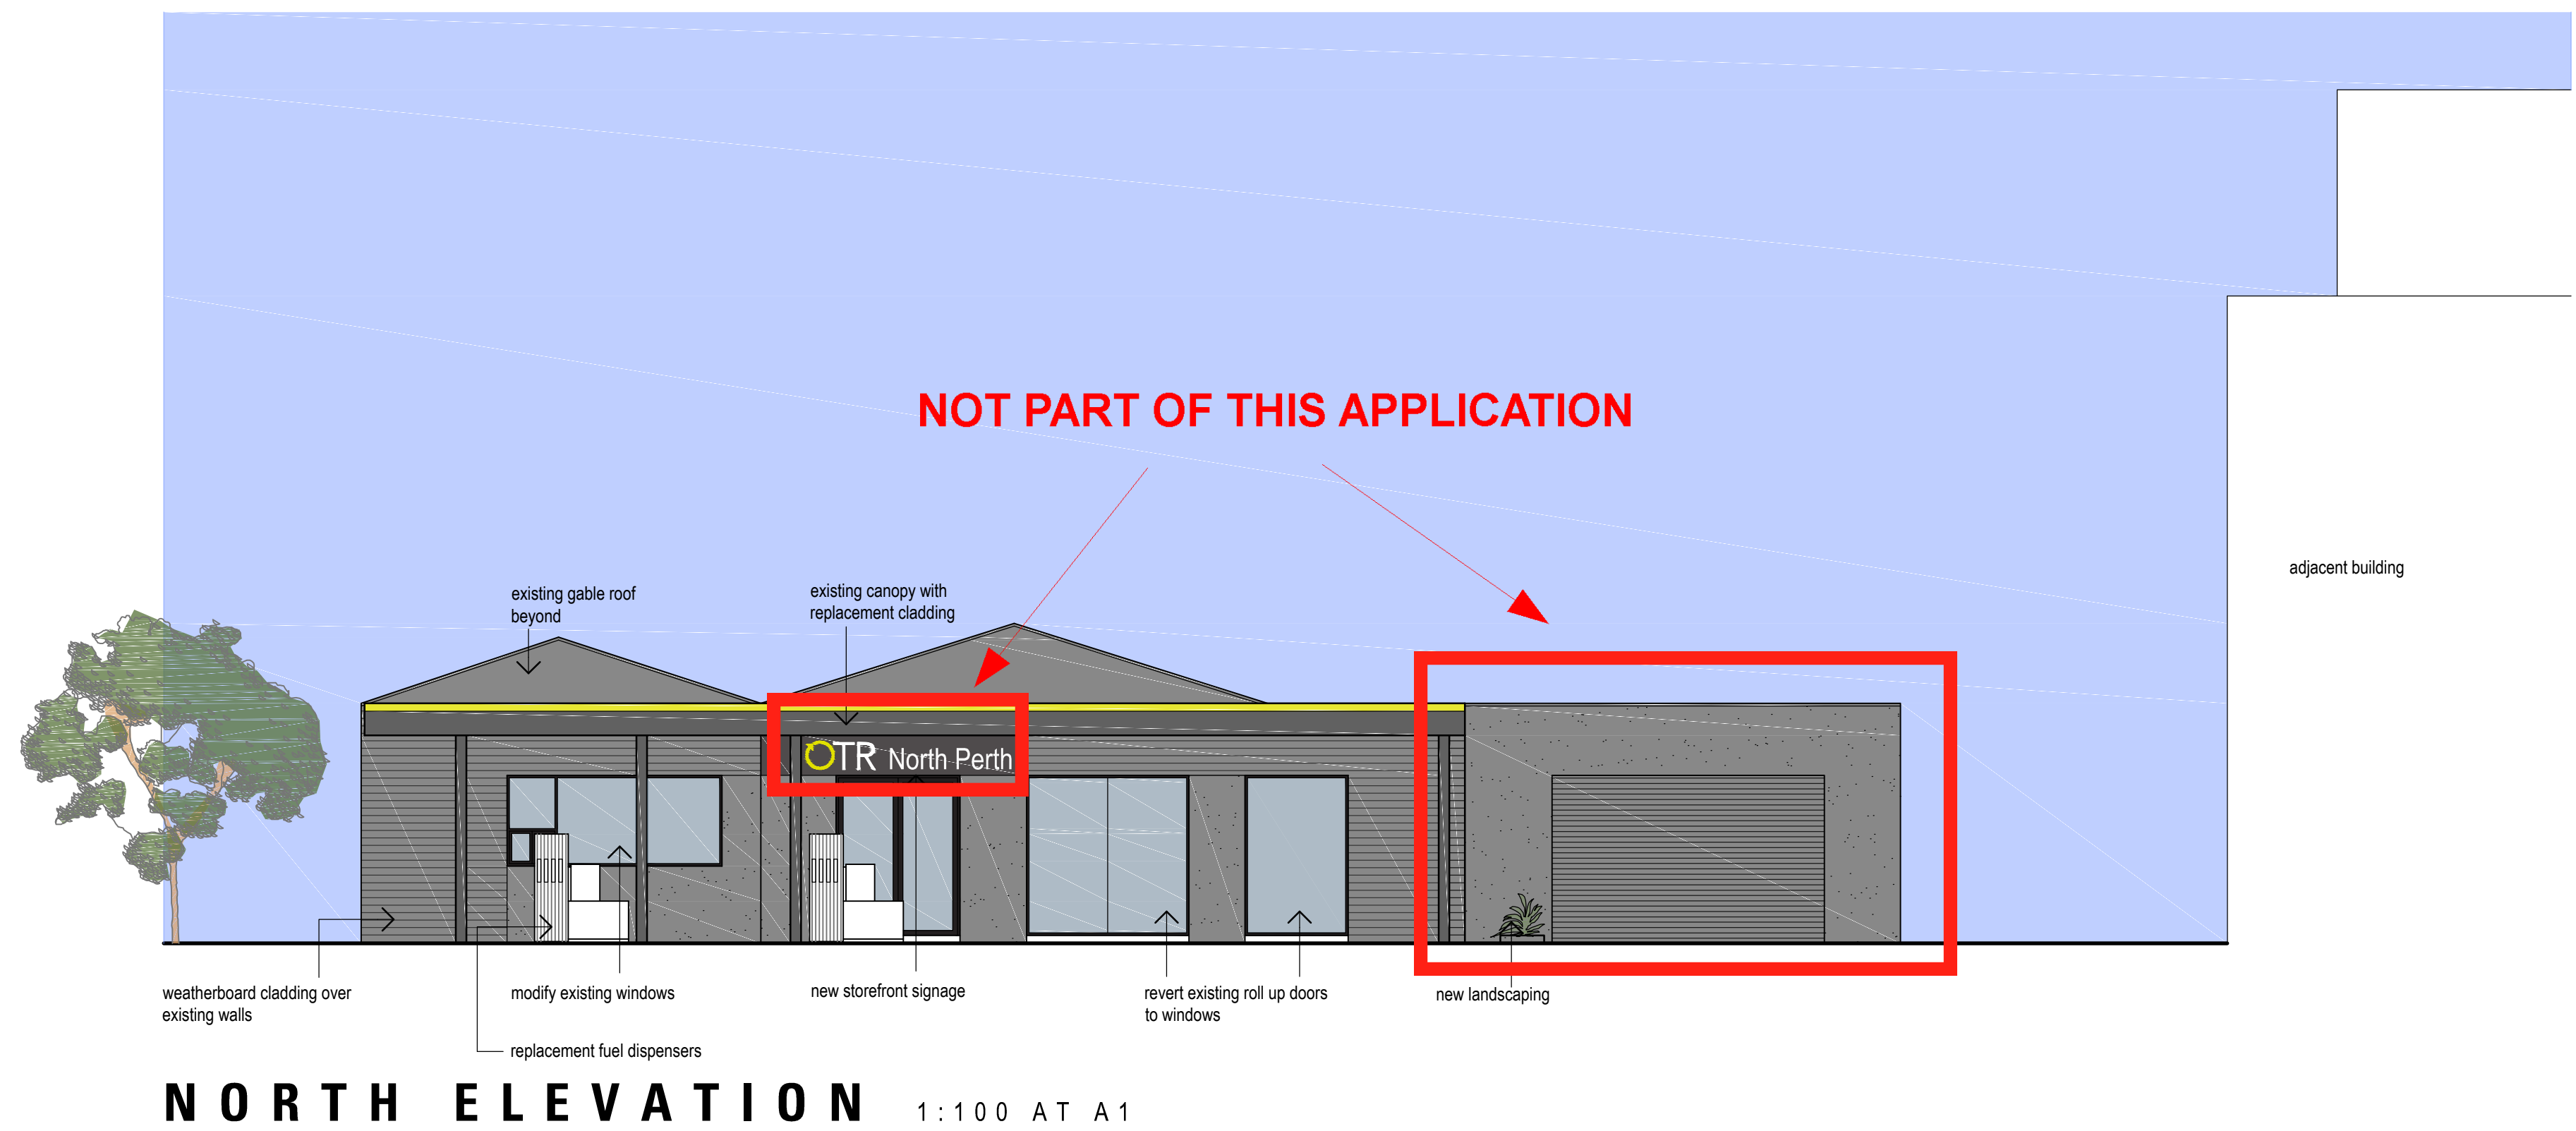
**implemented design elements**

- paint finish colour palette complements adjacent retail and commercial buildings on corner of Angove Street and Woodville Street
- retained gable, existing building heights and existing canopy heights maintaining low-scale built form character of the buildings in the locality
- contemporary design expressed through crisp design elements (weatherboard cladding) and additional glazing, to fit in with other contemporary built form in the locality
- changes to existing building on site improves and enhances use of site to customers and staff
- amenities on site improved current site conditions and will comply with applicable standards
- addition of landscaping on site enhances site and complements the locality including the established trees on Angove Street and Woodville Street
