Corymbia Consulting
Arboricultural Consultants

Tree assessment of two *Lophostemon confertus* on the verge of 48 Milton Street, Mt Hawthorn.

Mark Short, Grad Cert Arb, Dip Arb
12/03/2018

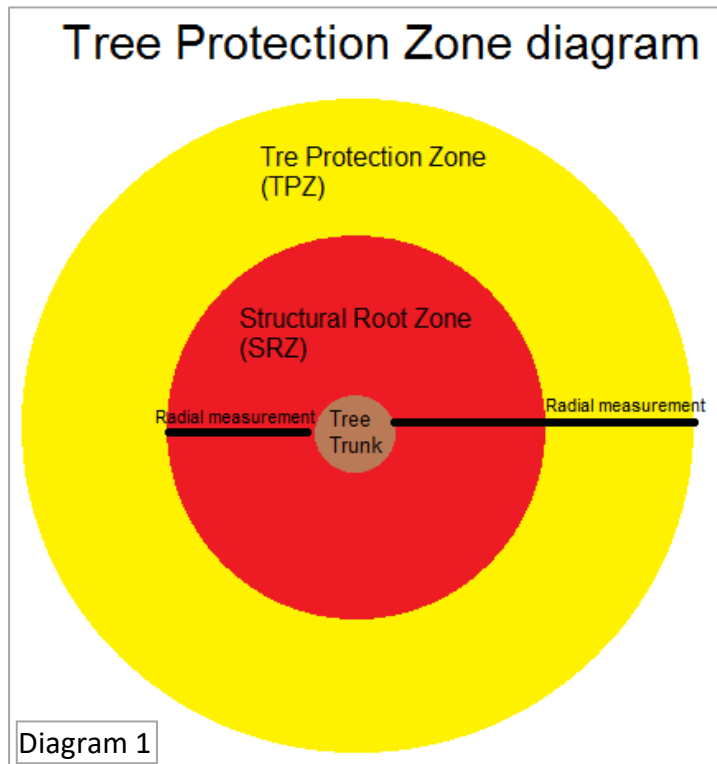
Even when working outside of the TPZ. It is important that any excavation works carried out around these trees is done in a radial pattern and not across the root plate of the trees (Diagram 2). When any mechanical equipment digs across a root plate they have a tendency to catch any roots in their path and pull against it. This action leads to damage further along the root and possible fracturing of the root crown where the root joins onto the base of the tree. This can then lead to death of the root and possible decline or even death of the tree. By digging radially along the roots this lessens the possibility of this type of damage occurring and will help to maintain the good condition of the trees into the future.
