**59 Ellesmere Street, Mount Hawthorn Visual Tree Assessment (VTA) –  
October 2022**

*Visual Tree Assessment (VTA)*  
*1x Jacaranda mimosifolia*

Reference number: Q005734

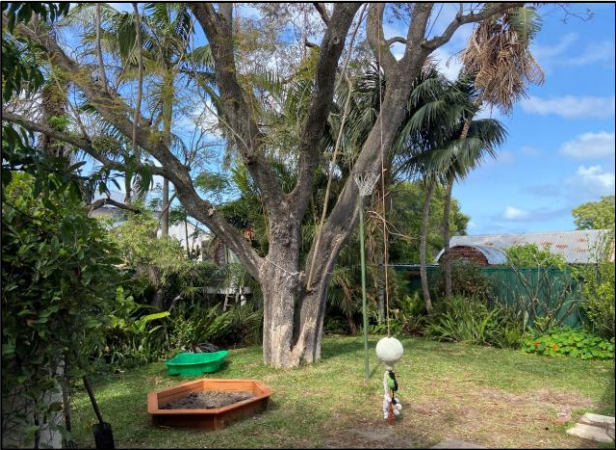
Several structural issues were observed including; previous deleterious pruning (i.e. tree has been lion tailed, however canopy structure could be remediated to offset previous works); stem failures ranging from 50 mm dia. to 150 mm in diameter; deadwood ranging to 50 mm in diameter, minor rubbing and crossing stems to 50mm, however; these issues are generally considered manageable within the scope of an ongoing, proactive tree management, canopy pruning and monitoring program.

- Tree presents a unique form; the excessive fluting is not a typical characteristic of Jacaranda's. The fluting appears to be in response to previous damage, however, the tree has stabilised well since the damage and still presents solid wood throughout the canopy.
- Inspection of the root flare and first order roots revealed no apparent soil cracks, root plate subsidence, heaving, or noticeable movement at ground level, with good root taper and minor fill noted to the North, East and West sides of the tree (<100mm) however is not considered as a concern at this time.

- That Corrective/Remedial Canopy Pruning be undertaken to address structural defects that were noted in the inspection;
- Aerially inspect the remainder of the canopy for potential structural, health and/or other issues that may not be detectable from ground level.

- That reinspection of the tree be undertaken in 2 – 3 years time (and/or following severe weather events) by the Consultant to assess and make further recommendations (remedial or otherwise) where required.
- Based on tree response to the short term corrective/remedial pruning, commence specialist remedial pruning to alleviate remaining defects from within the canopy and establish framework to enable future maintenance.
- Review undertaken of management plan every 5 years.
