CONSERVATION PLAN
REDEMPTORIST MONASTERY AND CHURCH
NORTH PERTH
JUNE 2011

Job Number 10154

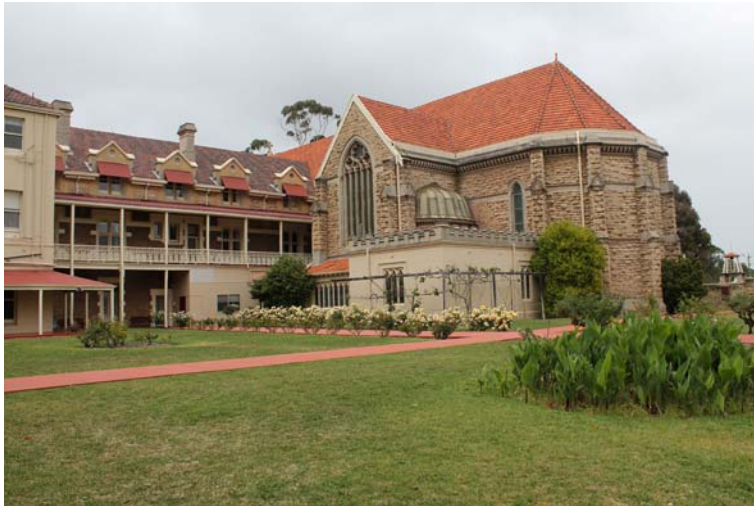
Photograph 55

View of the formal garden to the north of the monastery. The roof tiling looks primitive when compared with the original patterns.

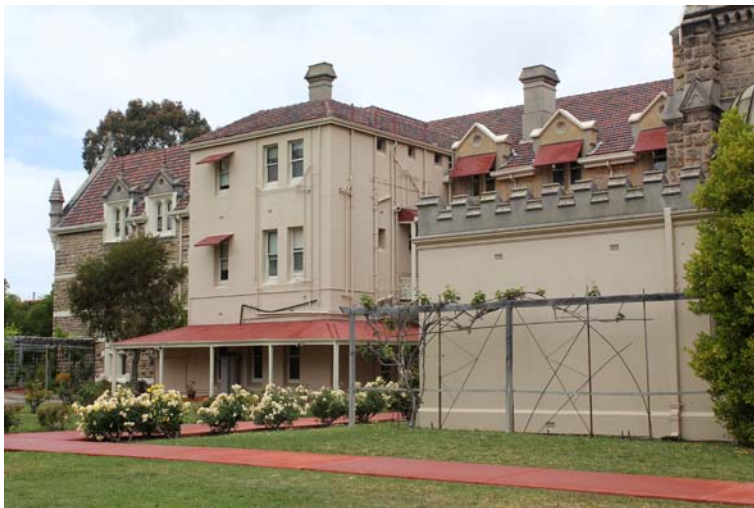
Photograph 56

View of the formal garden to the north of the monastery. A good deal of the stucco work has been painted to its detriment.

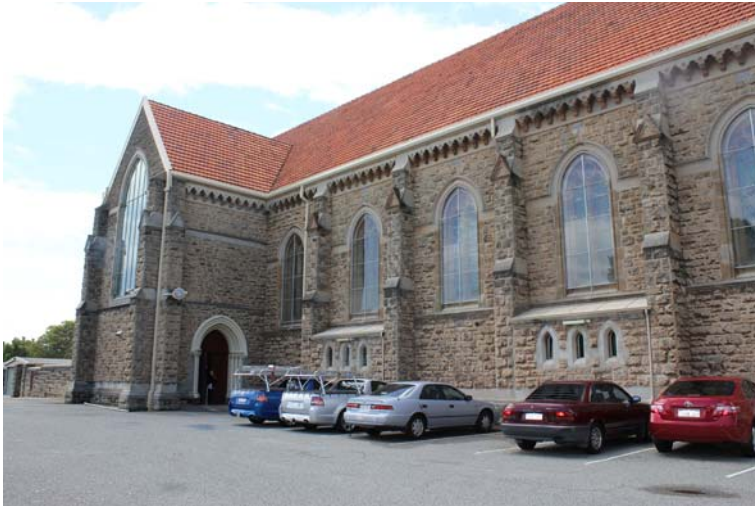
Photograph 74

View of the western elevation from the south-west. The entrance to the transept has been modified with the installation of a concrete ramp.

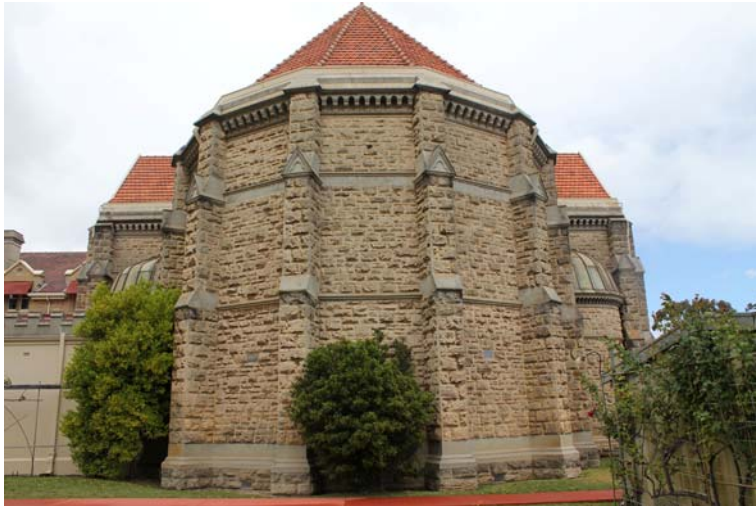
Photograph 76

View of north elevation of the sanctuary. The guttering has been modified through the fitting of a gutter to the top of the parapets.

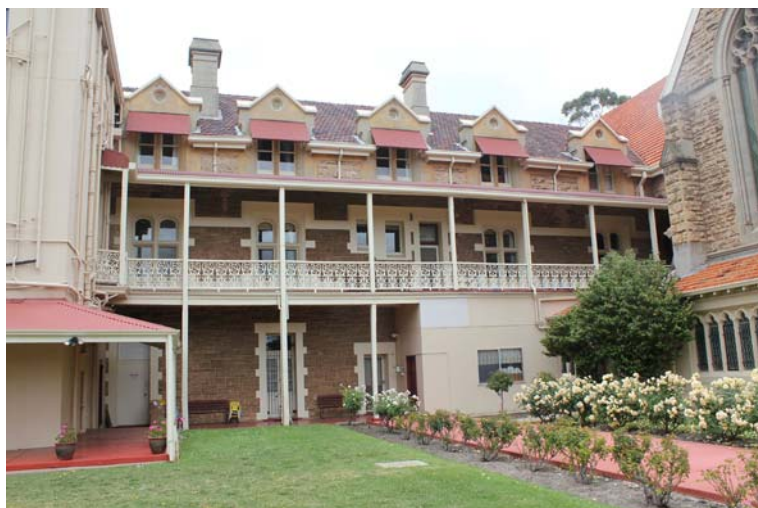
Photograph 79

View of the north elevation of the monastery building. The 1912 northern extension is to the left, and the 1922 church extension is to the right. Note the infilled area to the verandah and the hoods to the second floor windows are recent additions.

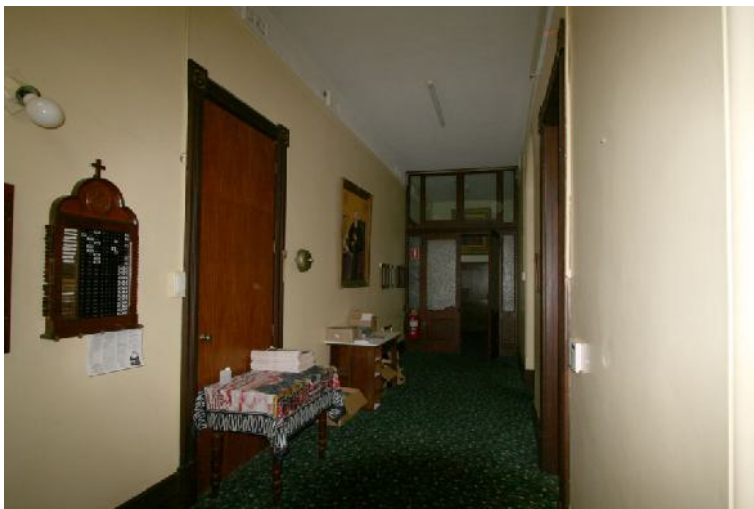
Photograph 82

View of the 1903 corridor from the east. Note that full height flush doors have been fitted to the rooms either side of the reconciliation rooms for soundproofing purposes.

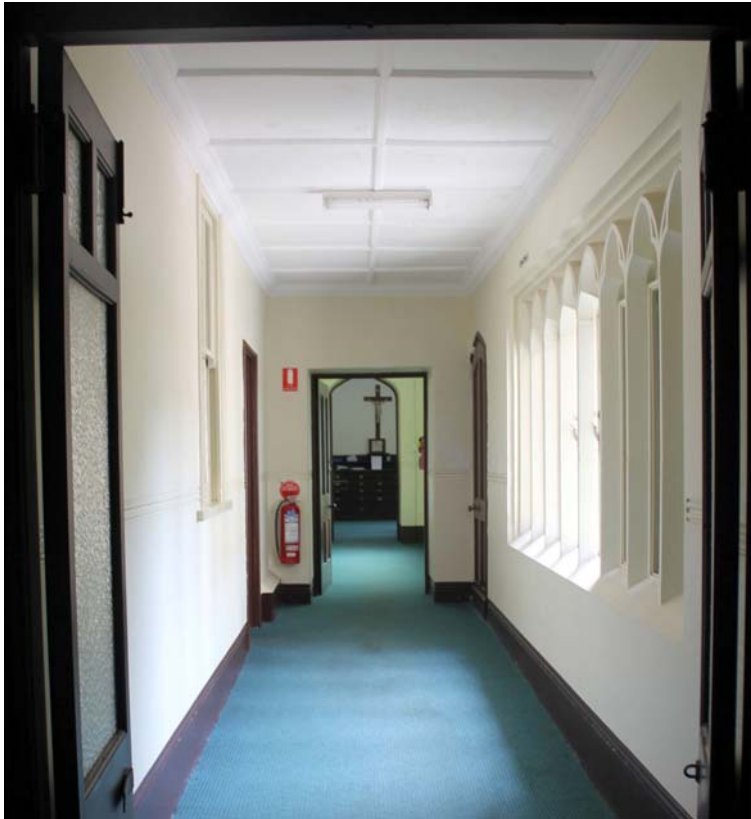
Photograph 87

View from the south of the corridor leading to the 1922 addition. The floor is carpet covered concrete and there is a floor drain, indicating that the cloistered windows may not have originally been glazed. There are persistent rising damp areas on the east wall.

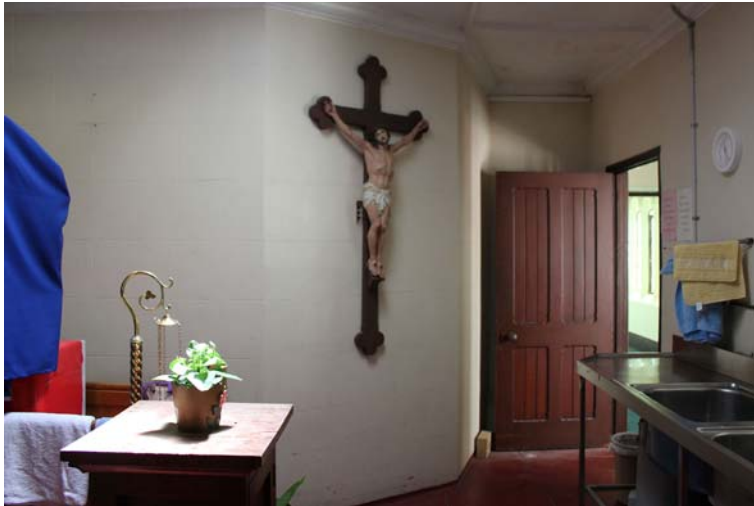
Photograph 89

Photograph into the working sacristy, which formed part of the link between the 1903 building and 1922 extension. Water staining indicates a number of roof leaks.

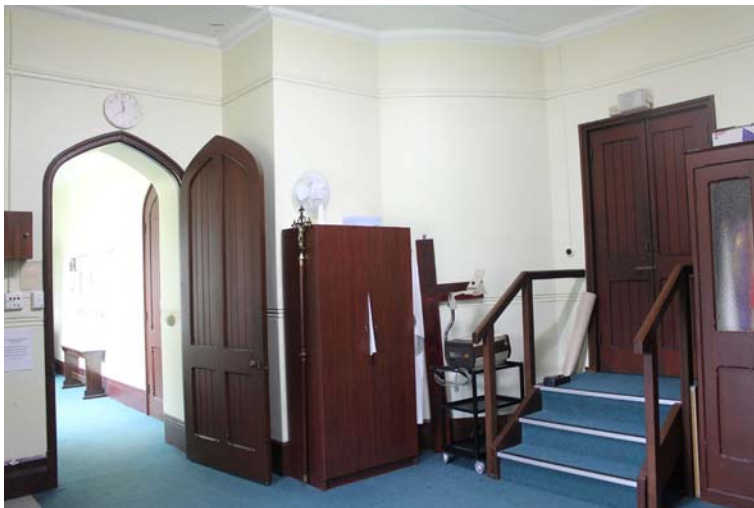
Photograph 90

View of the Sacristy from the north-east. The stairs lead to the Tribune, which is at the same height as the Sanctuary.

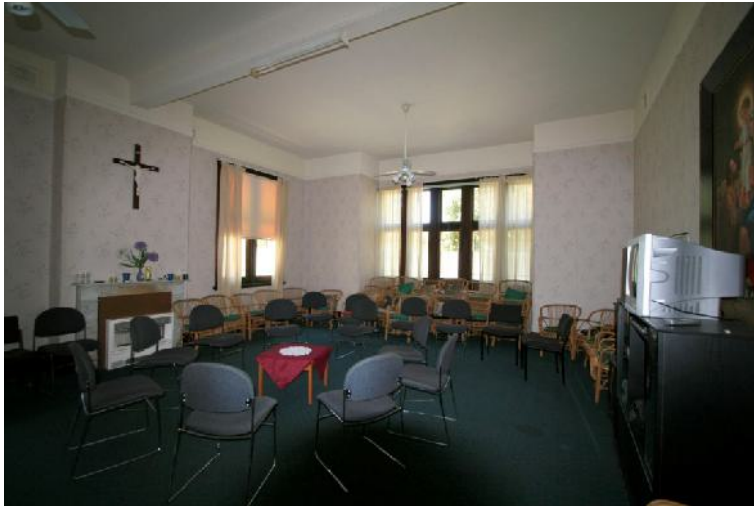
Photograph 95

View of meeting room (room 4) from the north. The walls have been wallpapered and the fireplace has been modified to house a gas heater.

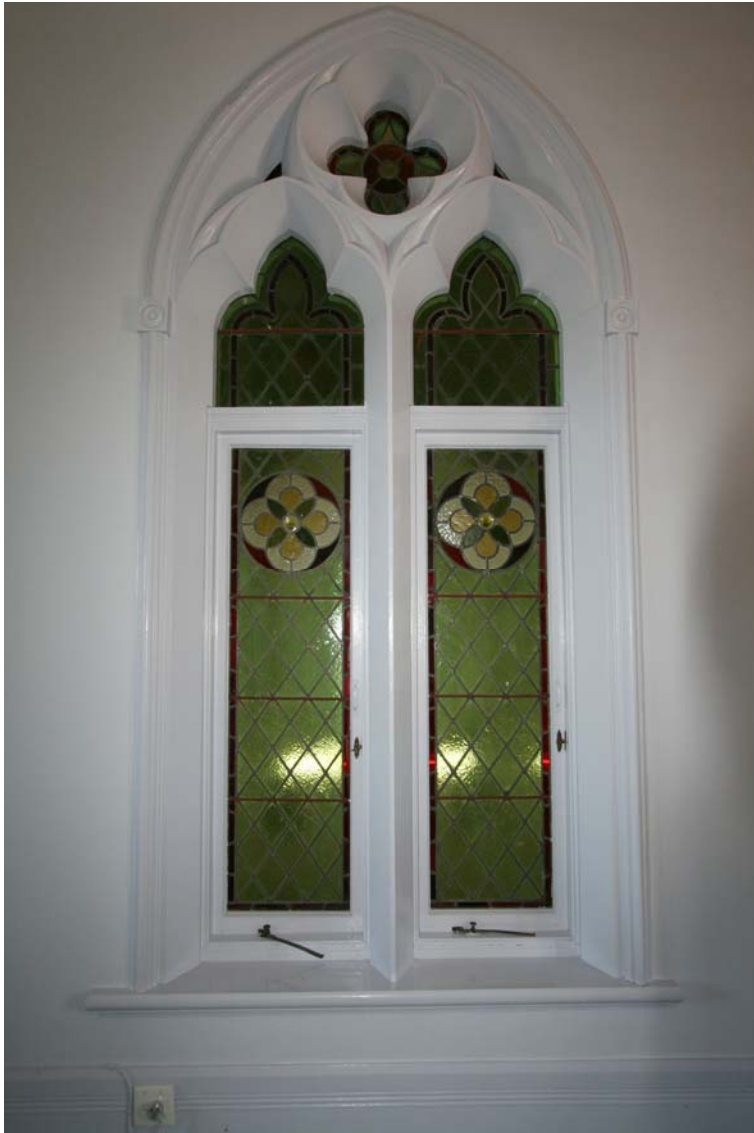
Photograph 103

Detail of one of the leadlight windows opening into the church. The windows are designed to match the exterior stucco windows, but are constructed from timber framing. The window used to contrast with the walls but have now been painted in with them.

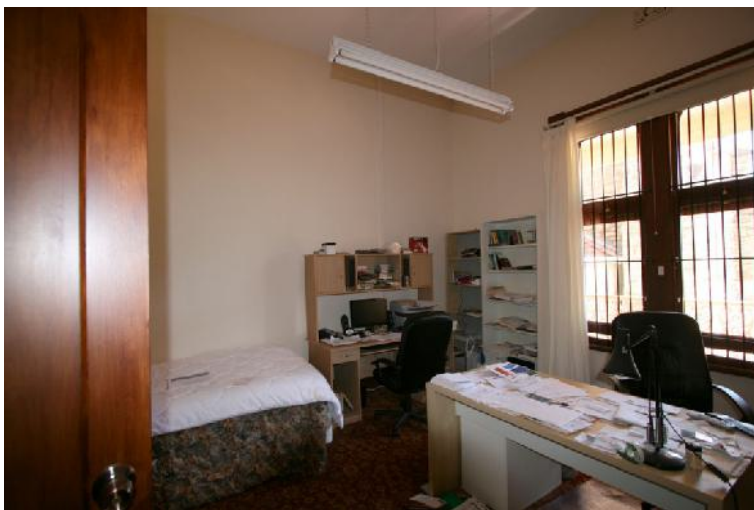
Photograph 104

View of room 18 from the south-east. The bars to the windows are a later fixing installed in many of the cells.

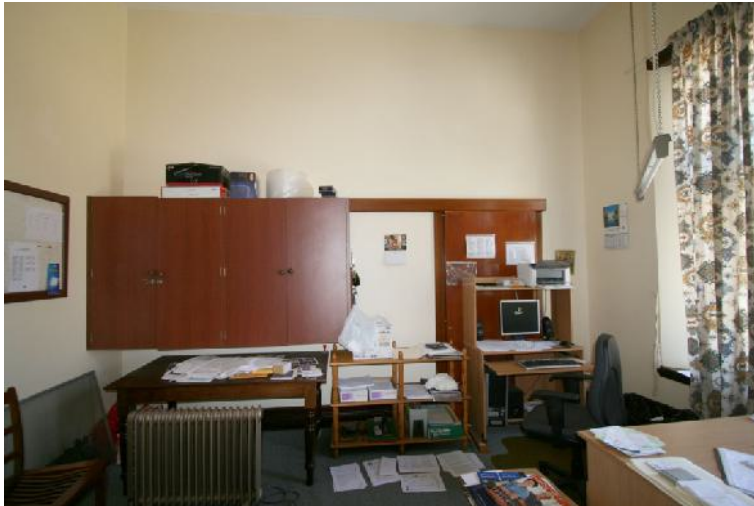
Photograph 105

View of the Rector's Office (room 16) from the west. The slide door was a later addition and is currently fixed shut.

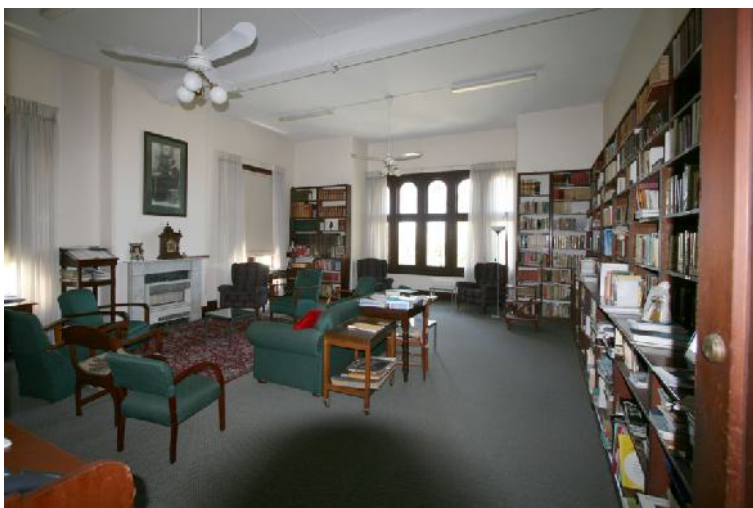
Photograph 110

View of the library (room 13) from the north. The fireplace has been modified for the installation of a gas heater, and plastic conduits are fixed to the lath and plaster ceiling. The shelving appears to be original.

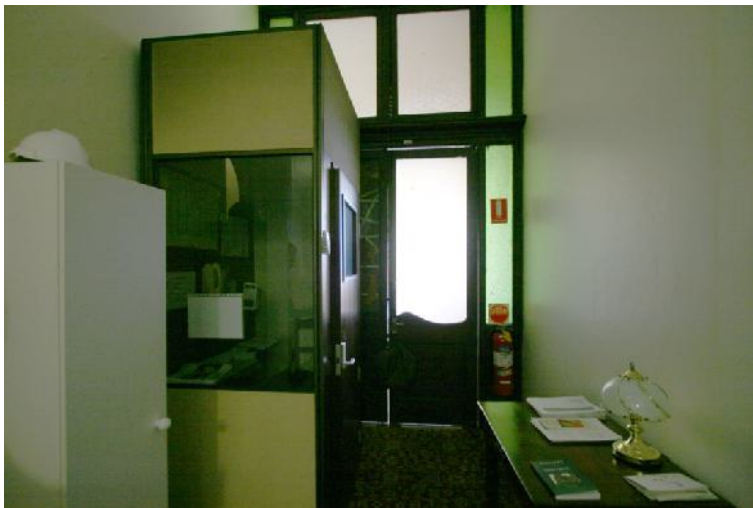
Photograph 112

View of the eastern end of the 1903 corridor. The doors lead out to the 1912 verandah, and the phone box is inoperable.

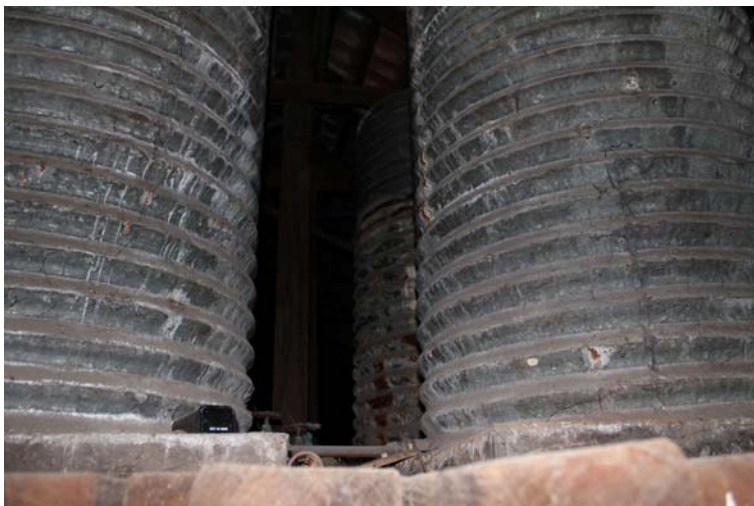
Photograph 122

Tanks located in the 1903 roof space of the monastery (accessed via a roof hatch from room 26A). The tanks are no longer plumbed in.

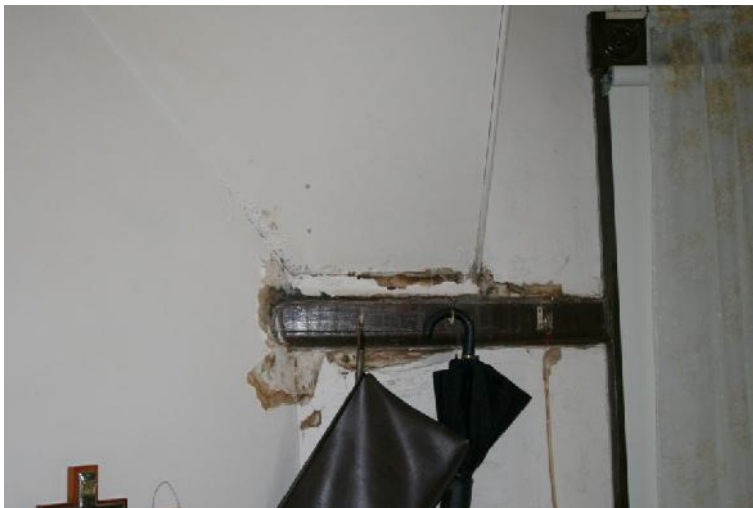
Photograph 124

Detail of the honey damage from the hive in the western wall of room 28. Note the fibrous cement cladding over the sloped lath and plaster ceiling.

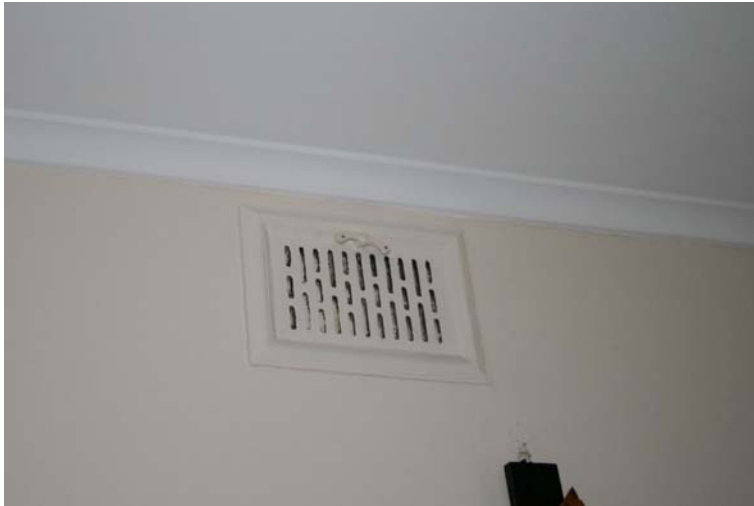
Photograph 126

Example of an operable vent. Most of these vents have been painted over, and thus, inoperable.

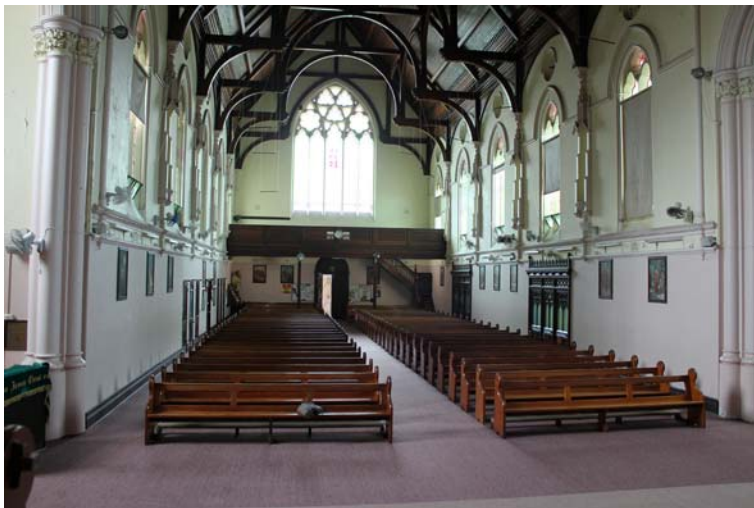
Photograph 132

Detail of church from the north, showing the choir stand to the rear and confessionals either side of the nave. The present colours cover a much richer original colour scheme and detail.

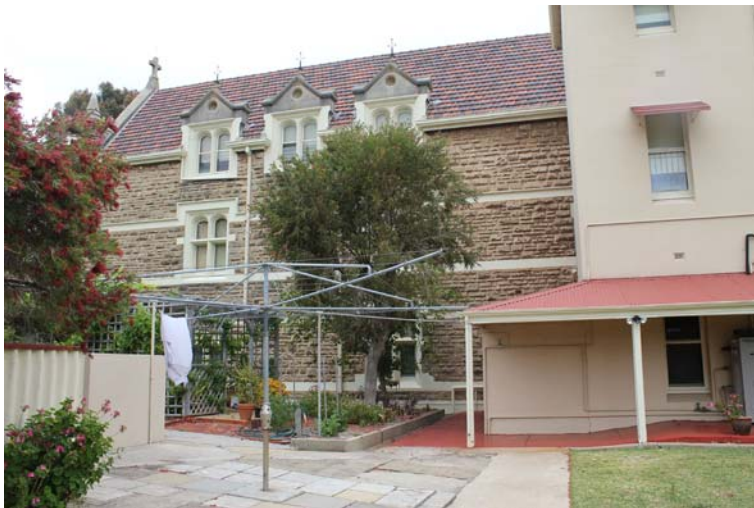
Photograph 151

View 1912 eastern extension of the monastery from the north, with the northern extension visible on the right. Note that much, but not all, of the stuccowork has been painted.

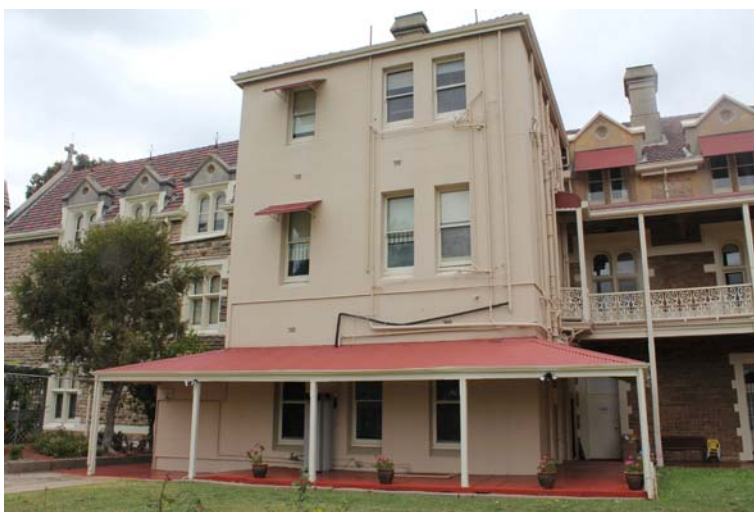
Photograph 153

View of the 1912 northern extension. The extension has been modified through the infilling of the ground floor verandah along the eastern elevation and the installation of a central window to the northern elevation.

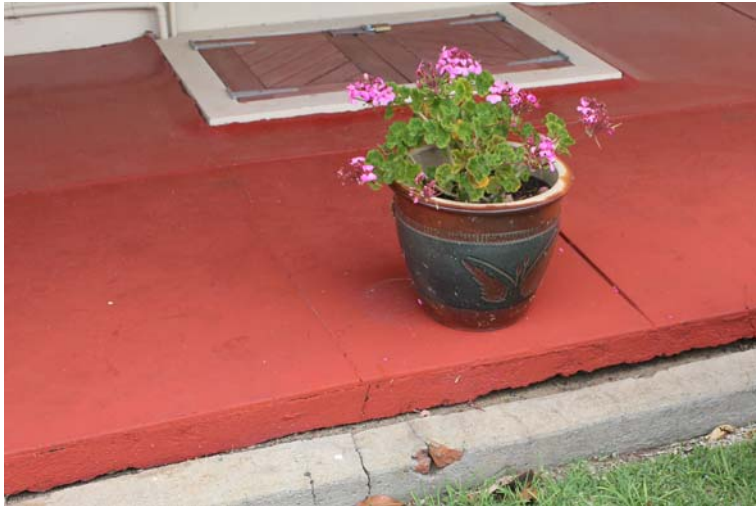
Photograph 154

View of the hatch to the basement. Note the high level of the of the verandah floor in relation to the ground level.

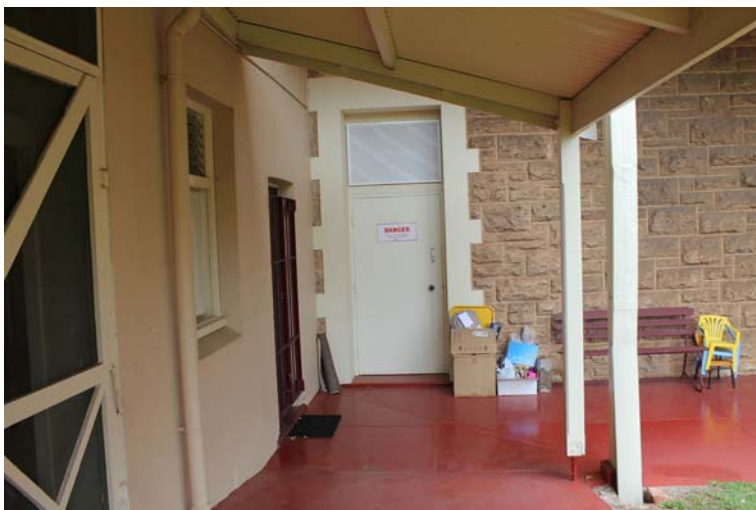
Photograph 157

View of the junction between the 1903 building and the 1912 northern extension at ground floor level. The door (centre) was fitted as part of the lift installation works in the 1990s. The verandah is now set well above the adjacent dining room floor.

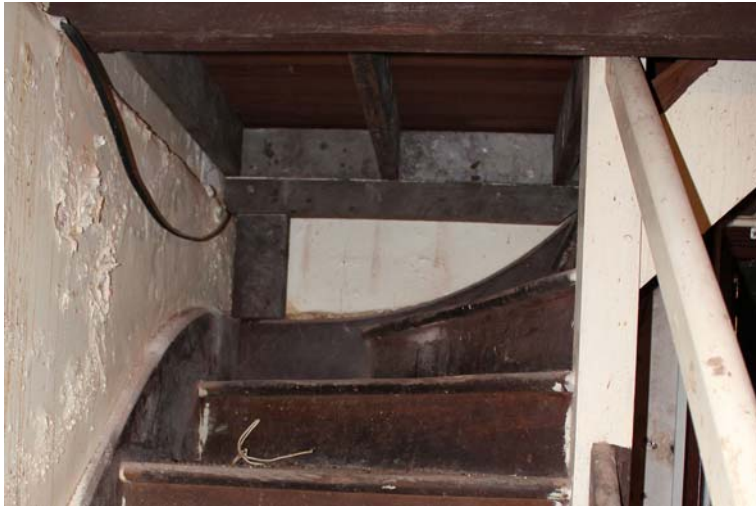
Photograph 159

Detail of the staircase. Note the damp to the walls.

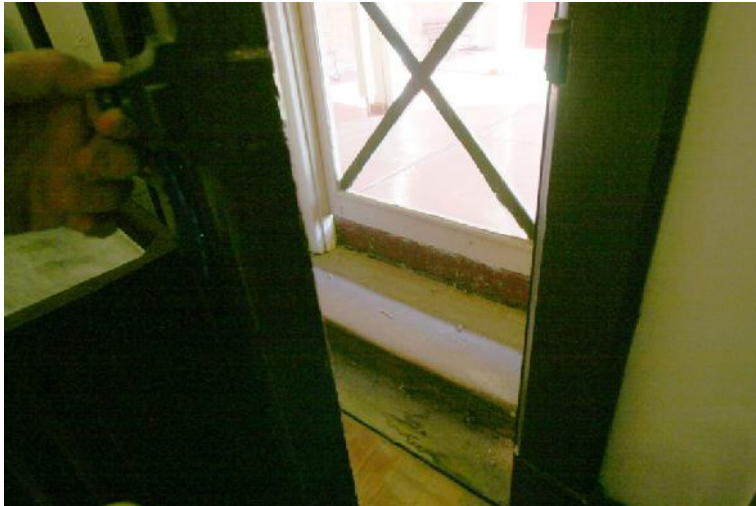
Photograph 164

Detail showing the built up floor level of the northern dining room's surrounding verandah.

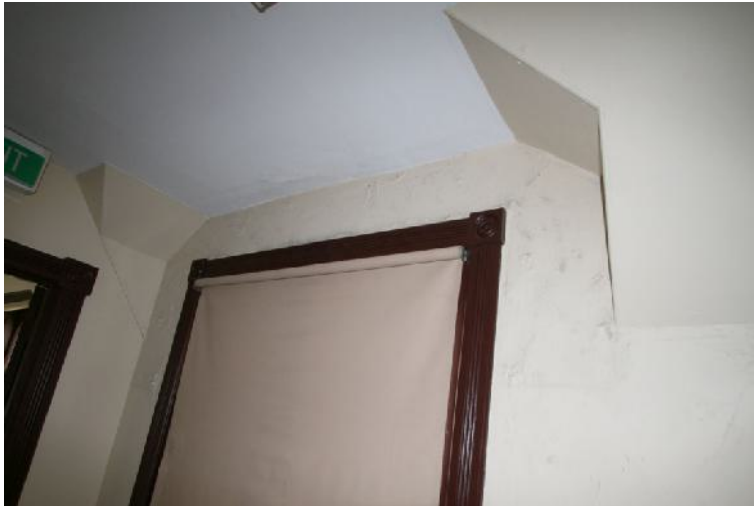
Photograph 186

An example of falling damp damage to a northern window, due to the failing of the valley gutters to the dormer windows.

The most significant issue is falling damp damage from failing valley gutters around the dormer windows to the second floor. Damage to the sloped ceilings around the windows has been repaired with fibrous cement lining⁸². There is also damp damage to the ceiling area below a junction gutter between the 1903 and 1912 structures. This gutter failing was caused by the March 2010 storm. Further damp in walls is extant in the common room (1912 northern addition) on the first floor, as well as in the west wall of room 28, continuing into the corridor. There is further damage to walls caused by deteriorated downpipes and a beehive located in the wall and roof junction of room 28.

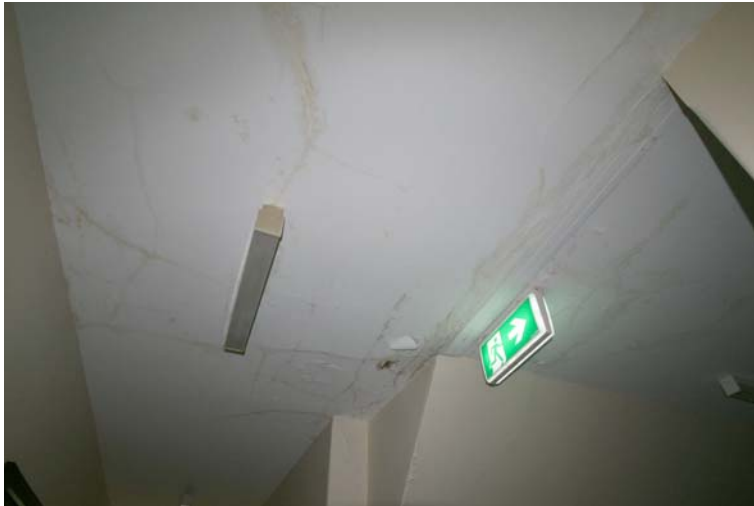
Photograph 188

Detail of extensive ceiling damage to the west end of the northern corridor, caused by failing gutters during the March 2010 storm. (The ceiling was later repaired in November).

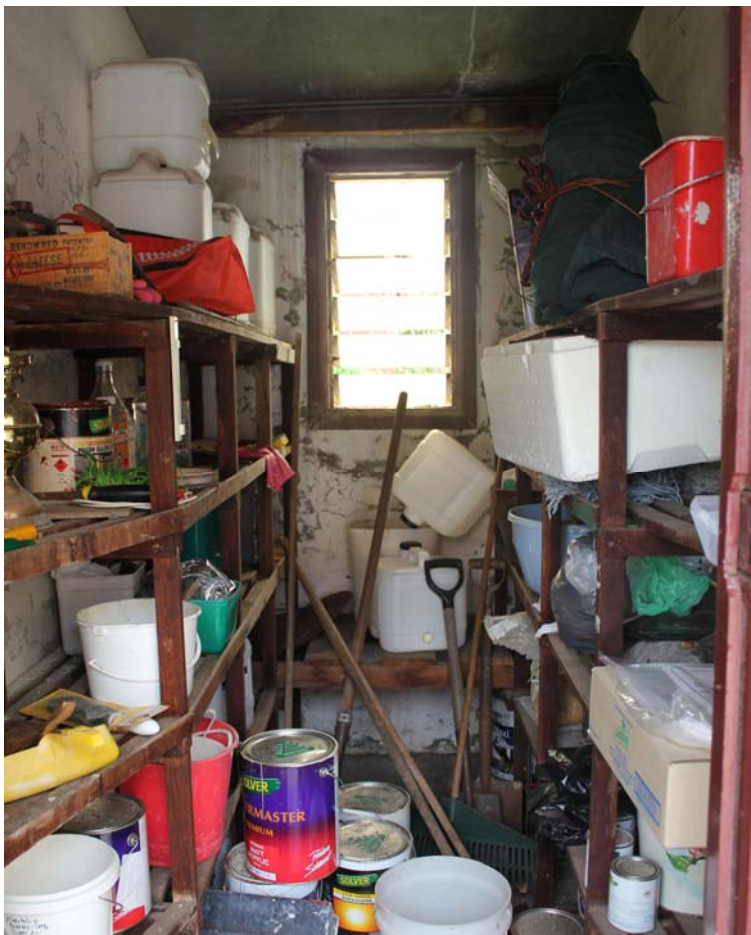
Photograph 205

View of the southern room of the laundry block. Note the blue asbestos ceiling and cement rendered walls.

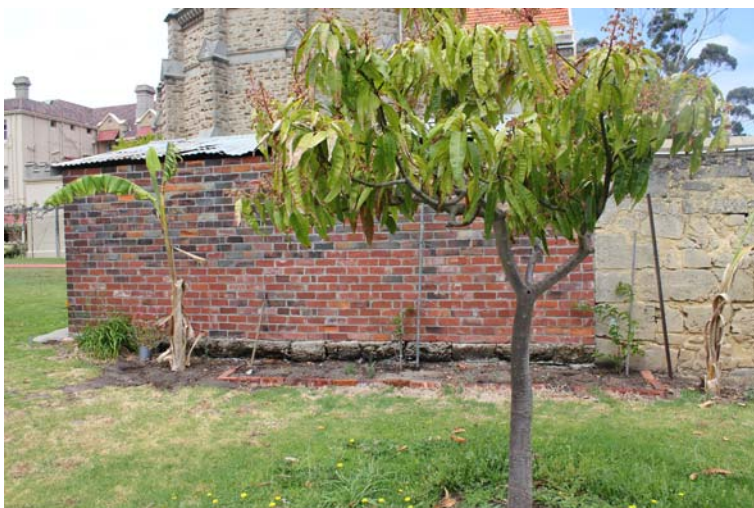
Photograph 211

View of the garage, located to the north of the church and accessed from the western car park. The pointing to the limestone wall is in poor condition.
