CITY OF VINCENT

Council Briefing

11 September 2018

5 DEVELOPMENT SERVICES**5.4 LATE REPORT: NO. 3 (LOT: 47; D/P: 1177) BULWER AVENUE, PERTH - EXISTING AND PROPOSED ALTERATIONS TO SINGLE HOUSE**

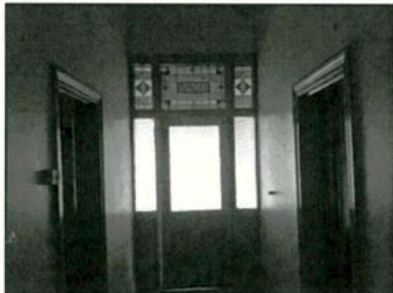
1.1. Common cracks noted. Not considered significant, however, should be inspected annually.

Common cracks noted.

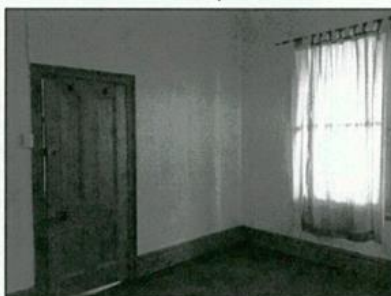
- 1.1. Cosmetic cracking noted, not considered significant, suggest repair to improve appearance.
- 1.2. Peeling paint observed.
- 1.3. Evidence of repairs observed, unable to determine the effectiveness of these repairs.
- 1.4. Dry at the time of the inspection.

Cosmetic cracking noted

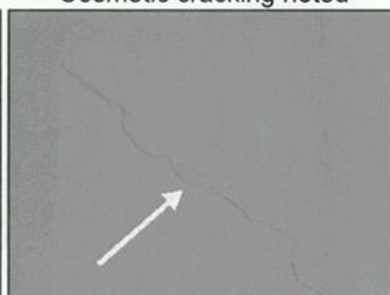
Cosmetic cracking noted

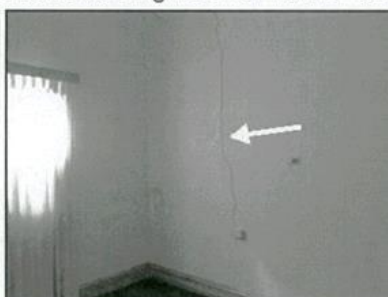
- 1.1. Cosmetic cracking noted, not considered significant, suggest repair to improve appearance.
- 1.2. Evidence of repairs observed, unable to determine the effectiveness of these repairs.
- 1.3. Dry at the time of the inspection.
- 1.4. Significant CRACKS in areas. Recommendations: Contact a licensed Builder or Structural Engineer for further advice and recommendations

Significant cracking noted.

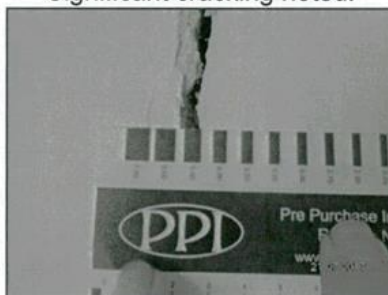
Significant CRACKS in areas.

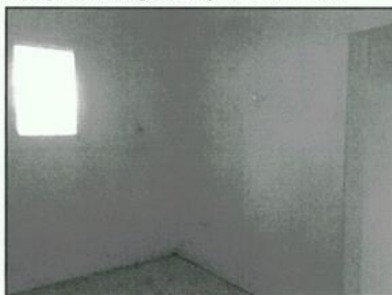
Cosmetic cracking noted

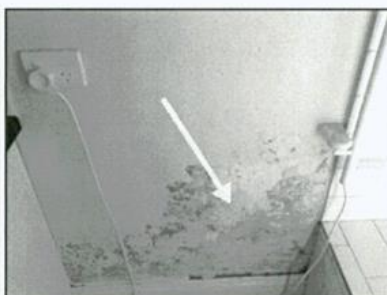
Past moisture damage noted.

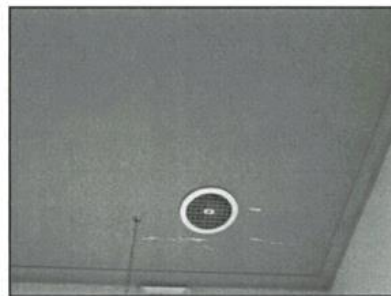
Peeling paint noted.

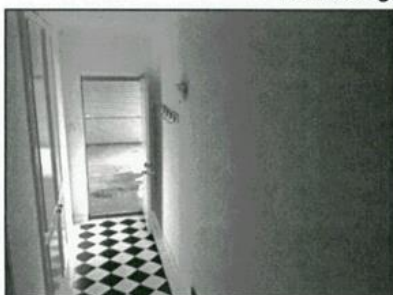
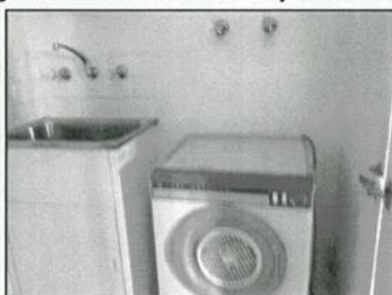
Cosmetic cracking noted

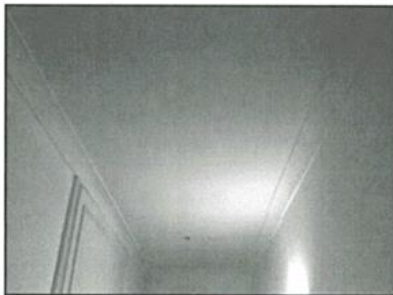
Common cracks noted.

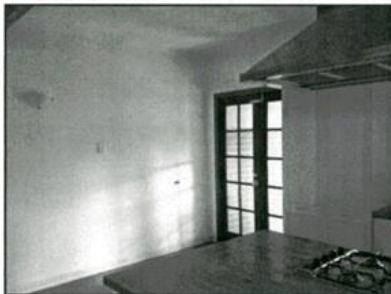
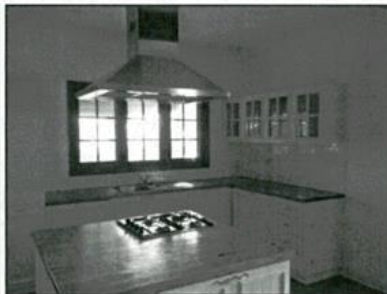
Cosmetic cracking noted

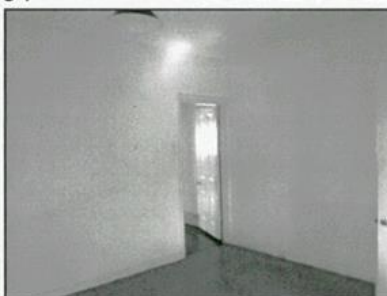
Cosmetic cracking noted

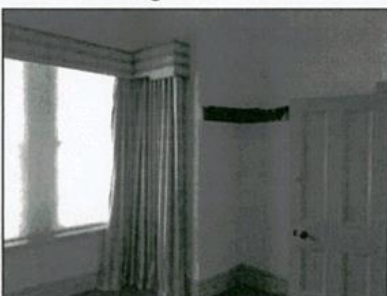
Cosmetic cracking noted

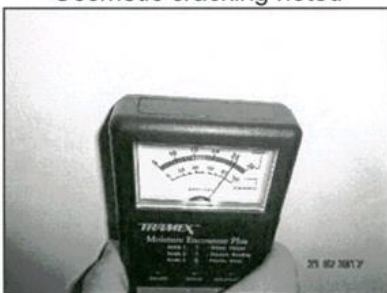
1.2. Moisture meter indicated a high moisture meter reading on the lower wall/s in areas suggest further evaluation by a licensed damp proofing professional. Instrument used to evaluate - Tramex Moisture Encounter Plus Moisture

High moisture reading noted.

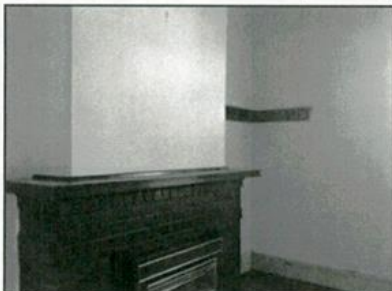
- 1.1. In serviceable condition at the time of inspection
1.2. Cosmetic cracking noted, not considered significant, suggest repair to improve appearance.

Cosmetic cracking noted

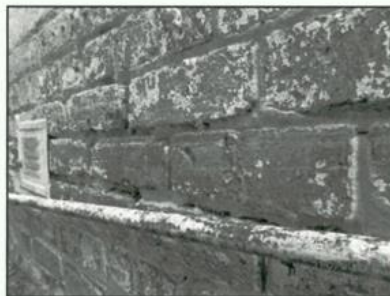
2.1. Deteriorated mortar observed.

Deteriorating mortar noted.

1.2. Mortar missing/deteriorated in areas, suggest tuck pointing as necessary.

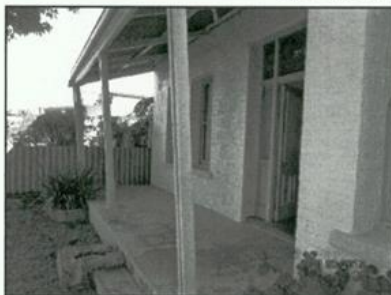
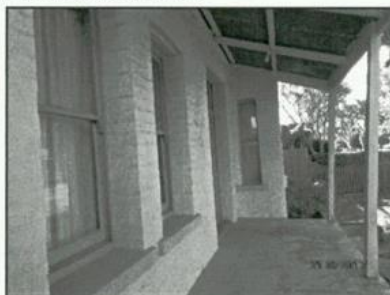
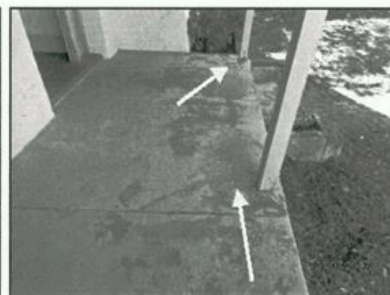
- 3.1. In serviceable condition at the time of inspection
3.2. Common cracks noted.

Concrete cracking noted.

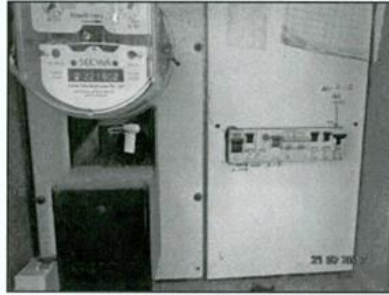
- 5.1. There are two RCD/s (electrical Safety Switch) installed but not tested.
Recommendation: have an licensed electrician test for correct function.

RCD's fitted.

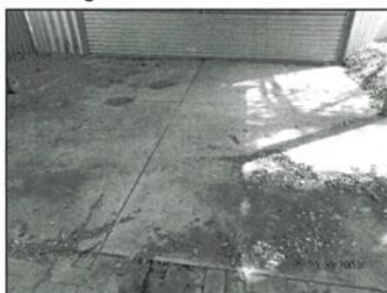
3.1. The item is performing the function it was designed for and in typical condition for its age.

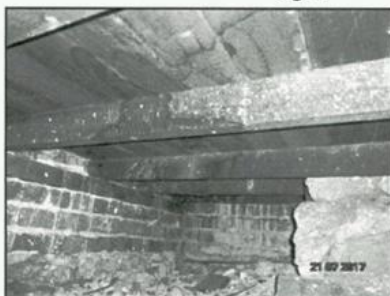
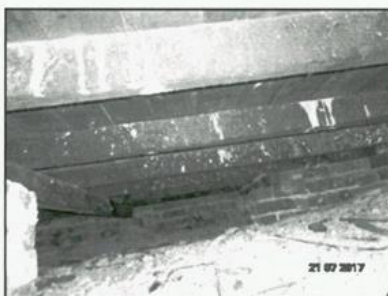
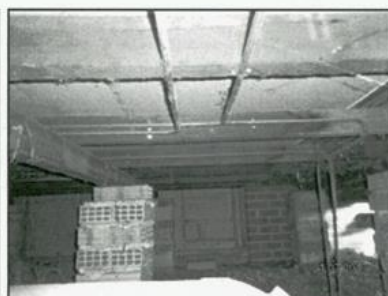
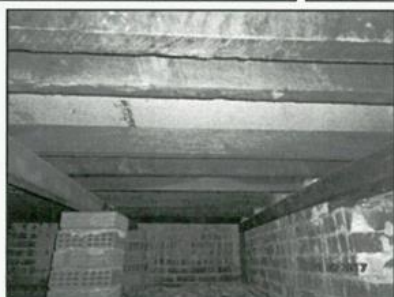
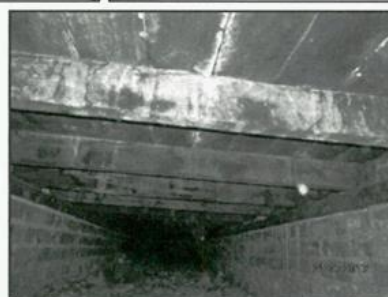
1. Bearers/Joist Condition

1.1. The visible Beams and joists appear in acceptable condition relation to age.

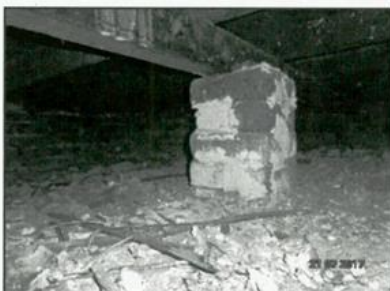
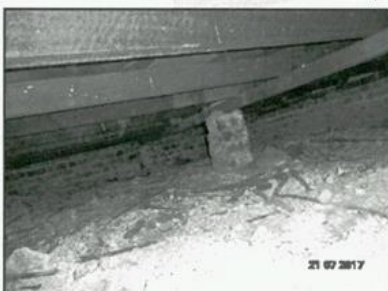
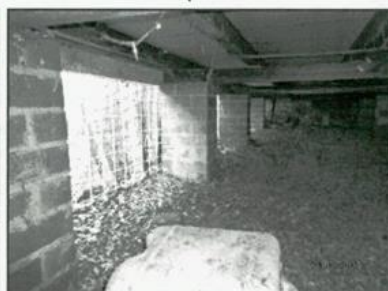
2. Support Post/stumps Comments

2.1. No deficiencies noted on visible areas, at the time of inspection.

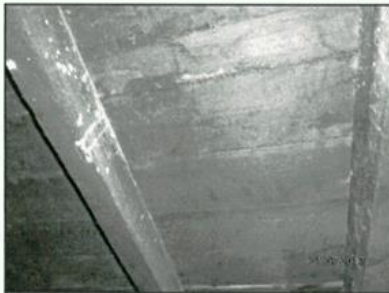
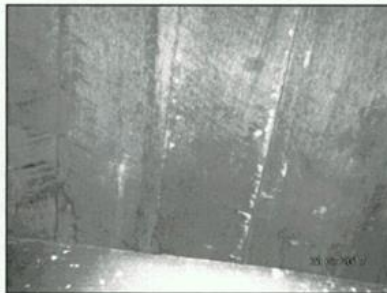
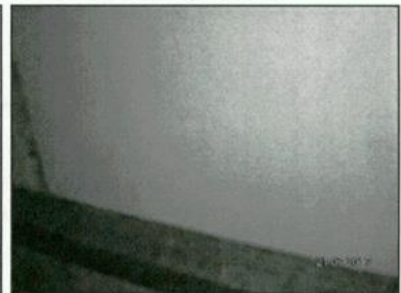
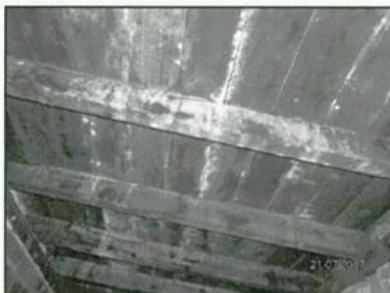
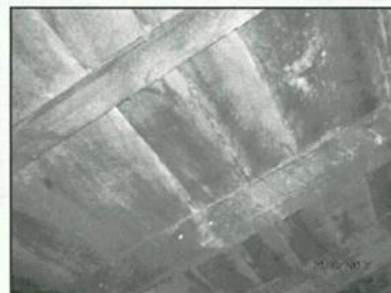
3. Subfloor Condition

3.1. No deficiencies noted on visible areas, at the time of inspection.

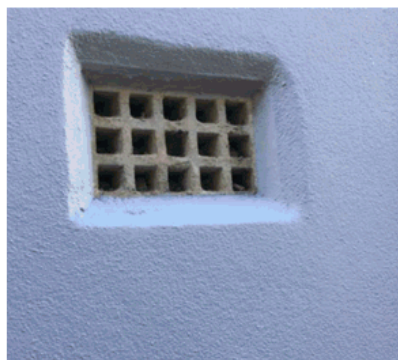
Ties the old with the new

I think this is far prettier and tidier

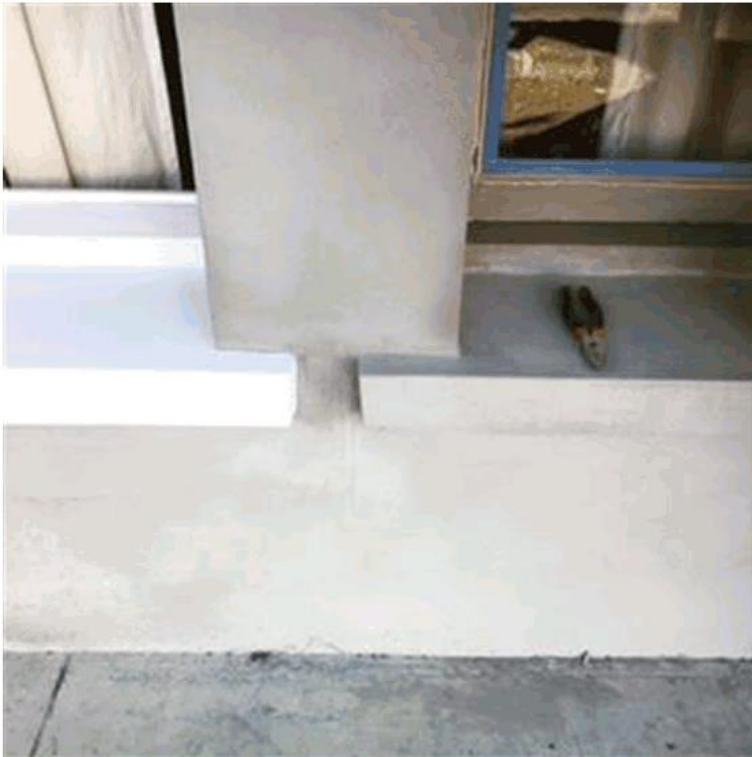
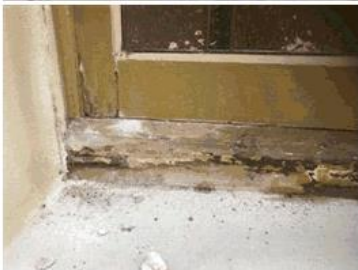
Moisture vents installed – there are six of these in total to remove future water. These did not exist!

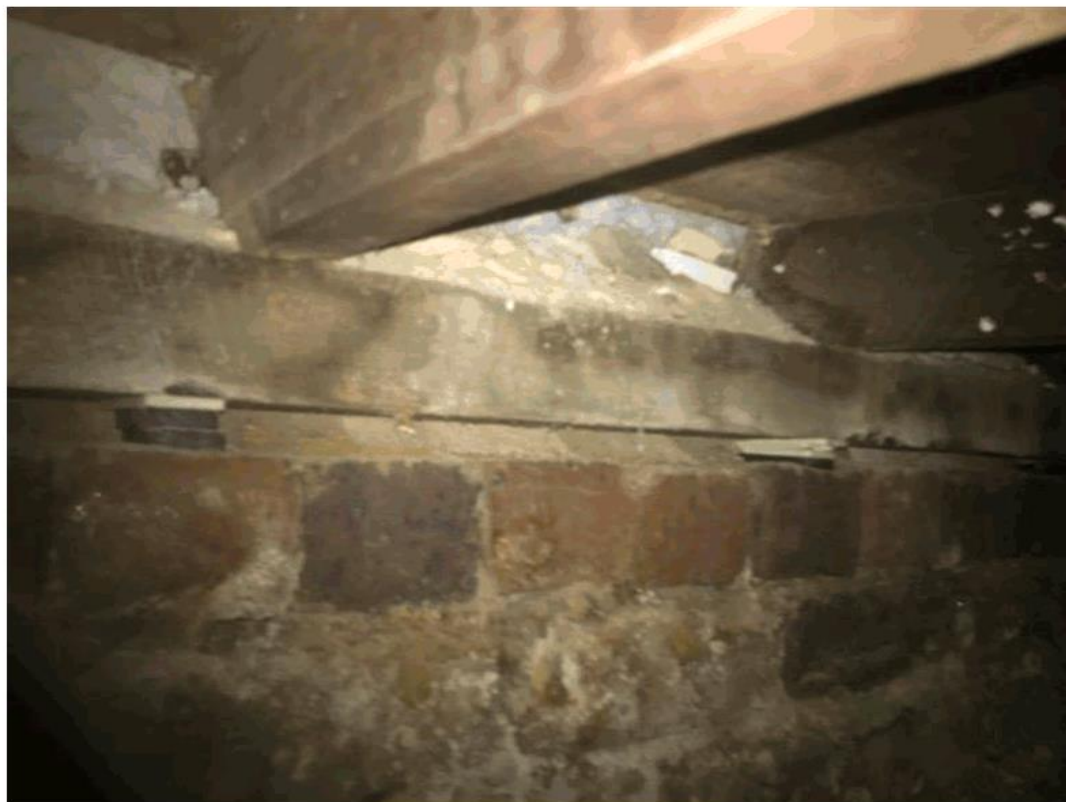
Internal Bed 3 floor raised and rebraced

Chucks to maintain the flooring are below

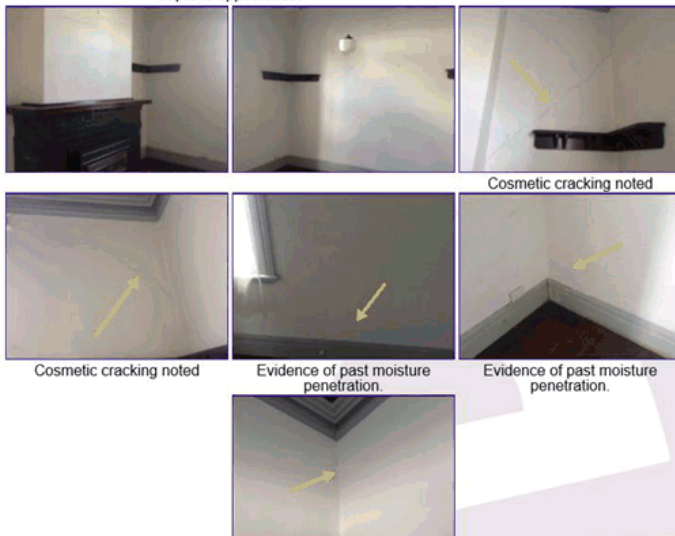
Observations:
1.1. In serviceable condition at the time of inspection
1.2. Cosmetic cracking noted, not considered significant, suggest repair to improve appearance.

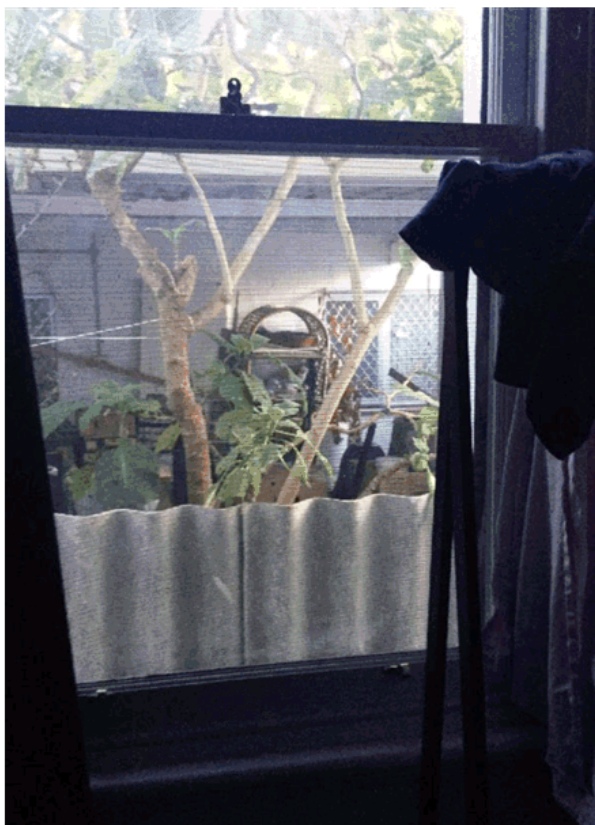
Window (replaced by Sasha in a flash as the wood holding the glass in place was no longer wood—ignore the mess—I gave the guy one hour's notice) The render on the outside wall will prevent water exposure. The wall was replastered to remove the bubble look

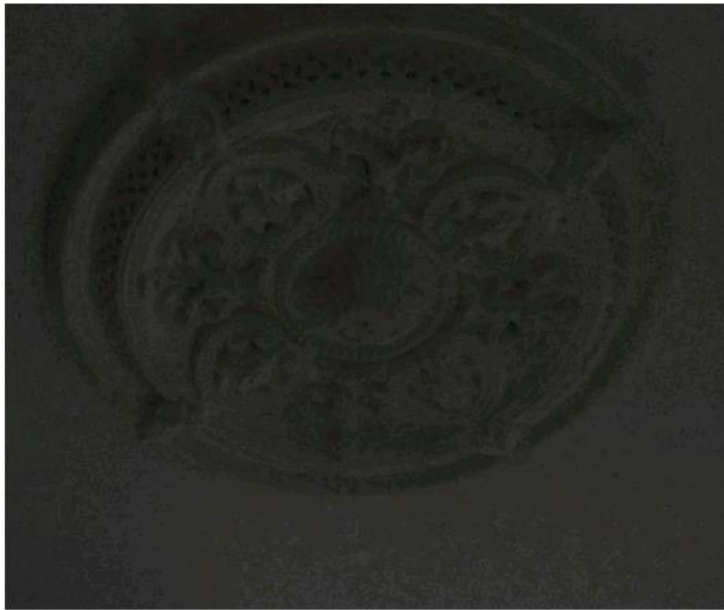
This is a huge corrieal most
60/70 cm Federation style
fiberglass

The ceiling rose – the light has
not been installed yet.

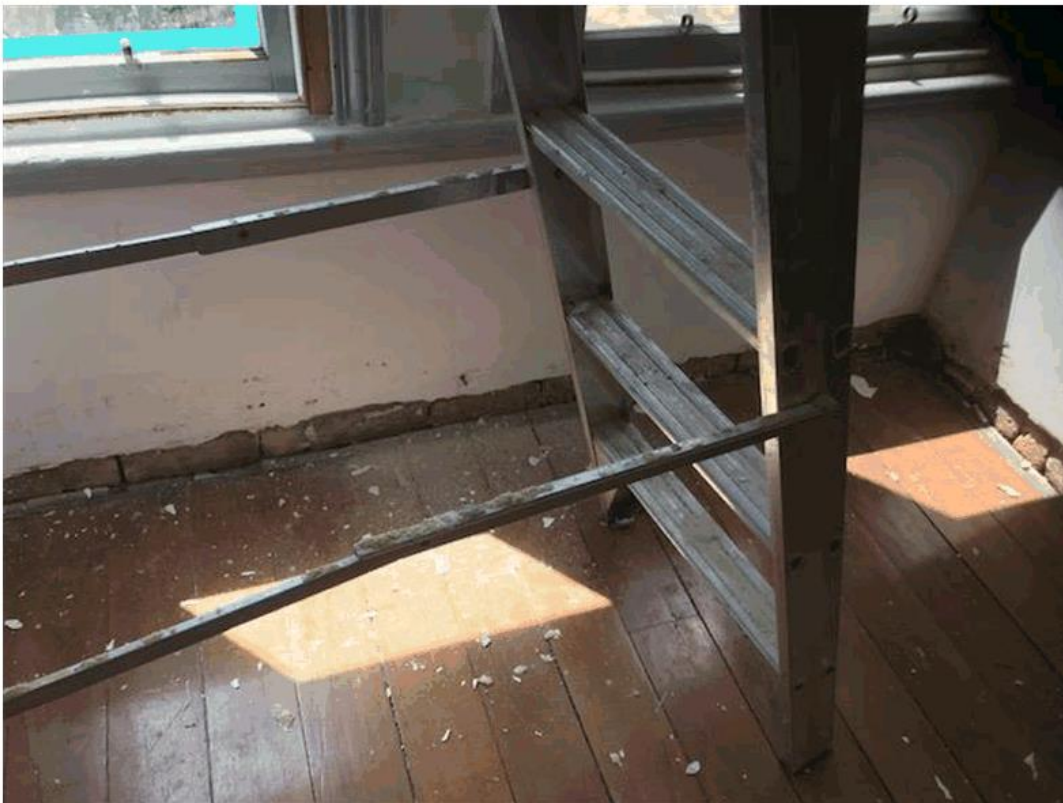
Crack repaired after wall rebraced –
mentioned above.

Part way through...

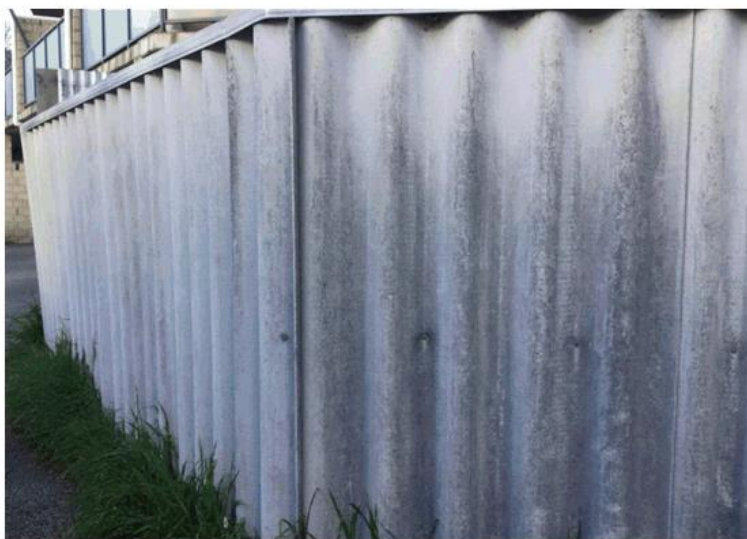
Wall is on a lean and is low. This is the location several people have jumped the fence.

Would like to raise to the allowed height.

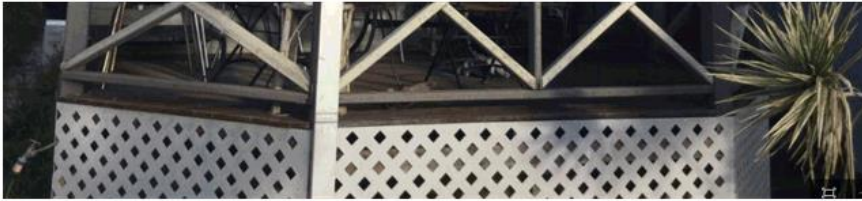
Oops – this was bamboo – I replaced it to lattice – I plan to paint it.

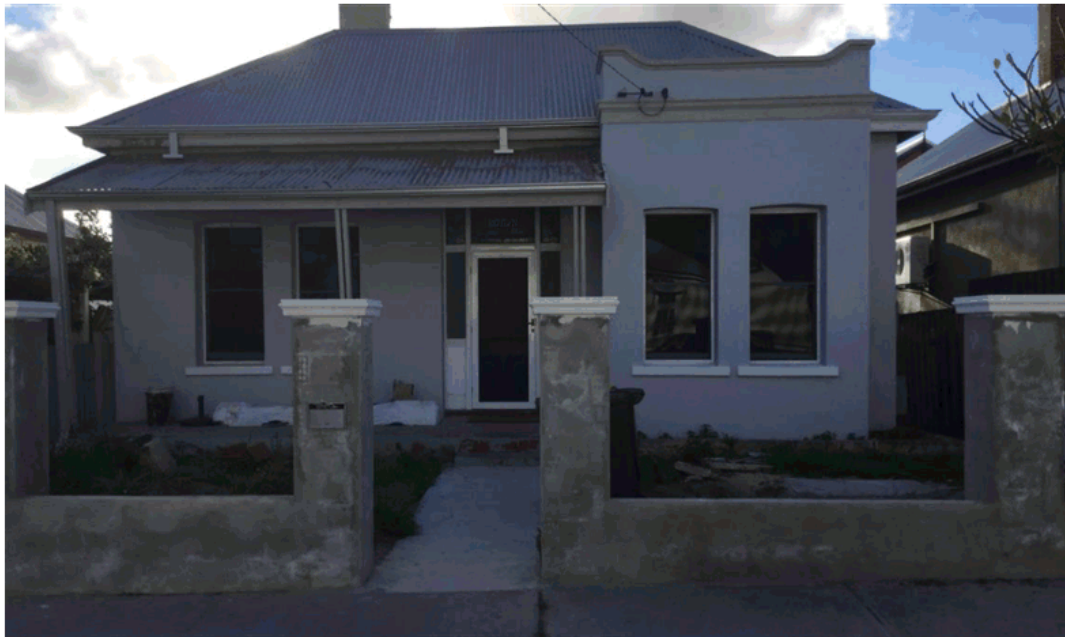
Rotten wood replaced. Still needs painting

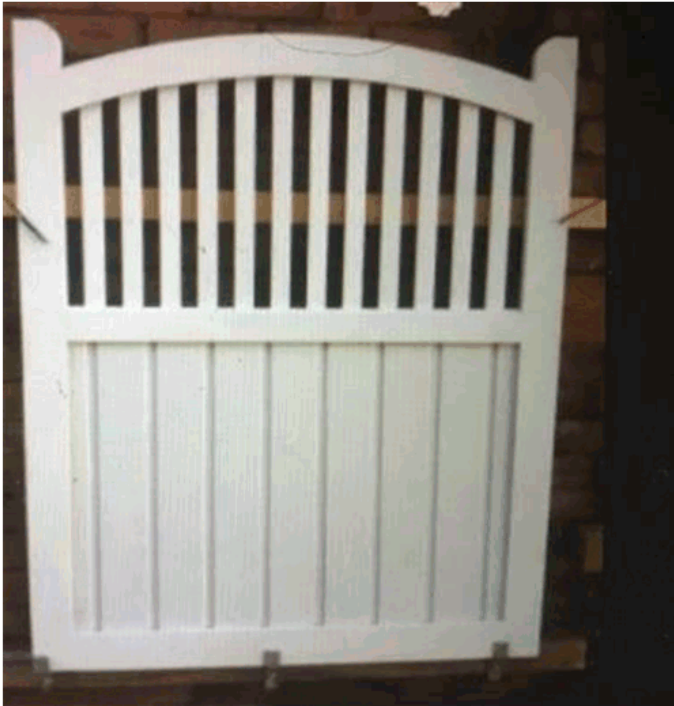
Posts purchased for front patio –
gate not yet purchased for side
replacement

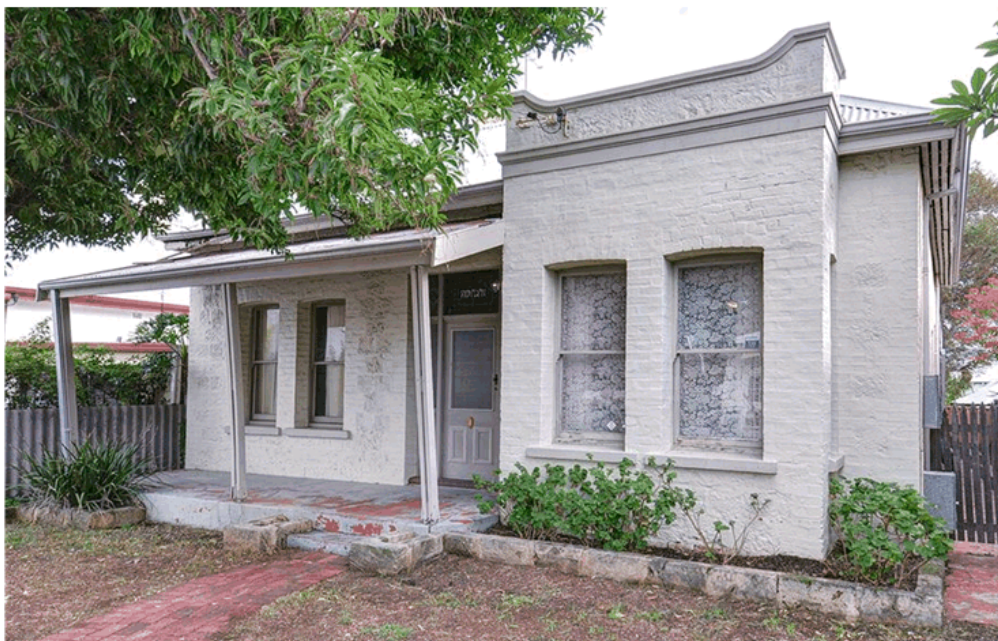
Figures 2 (REA Group Ltd) indicates that the original limestone and brick walls were pointed and painted white, prior to the 2017-18 works. Following the 2017-18 works, the front (east) and side elevations comprises concrete render, being painted in a light purple colour. Figures 3-4 (element, 2018) demonstrates the architectural composition the building following the 2017-18 works.

Figure 2. BEFORE 2017-18 WORKS. View of the southwest elevation of the subject place prior to the 2017-18 alterations, noting the painted limestone, brick and roughcast wall which is now rendered over (REA Group Ltd, 2017).

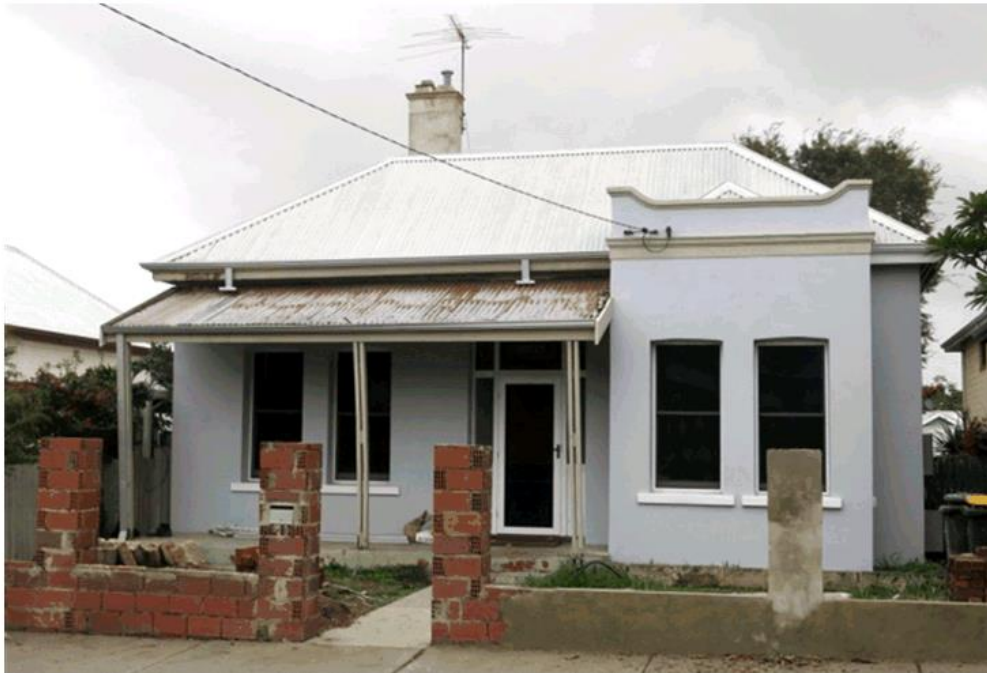
Figure 3. AFTER 2017-18 WORKS. The subject place in May, 2018 (**element**).

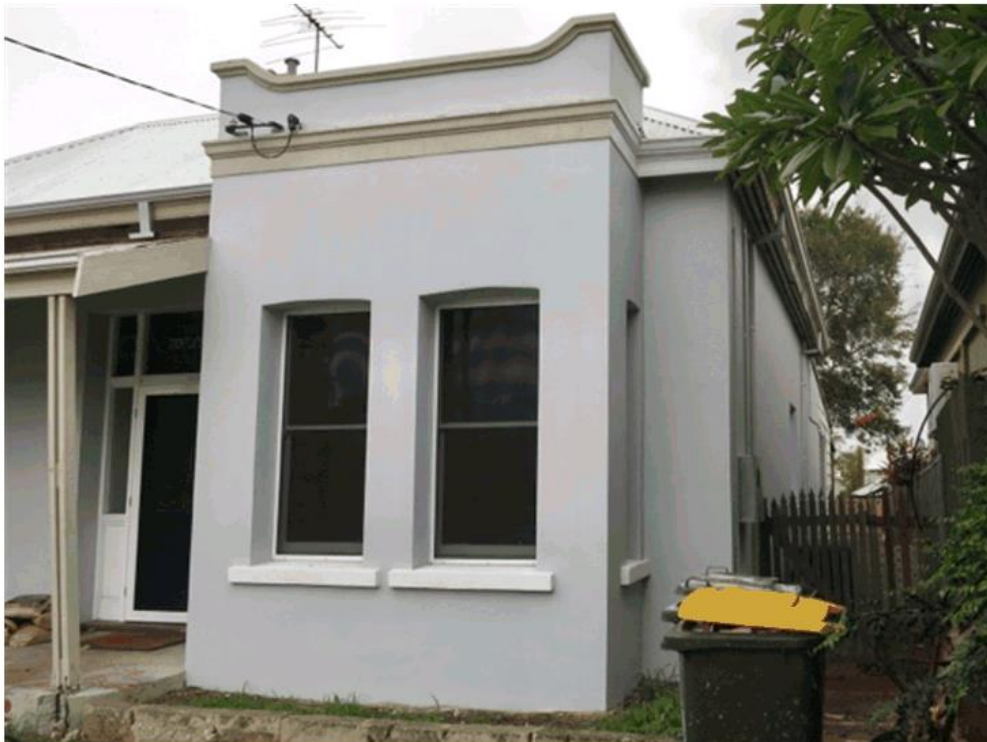
Figure 4. AFTER 2017-18 WORKS. East and north elevation in May, 2018. Note the rendered limestone and brick façade, side elevation and roughcast parapet feature (**element**).

- Concrete render and acrylic paint is not a suitable application for limestone or masonry, as it contributes to the retention of moisture within the substrate, thereby accelerating deterioration of the original wall structure.

The concrete rendering to the limestone and brick façade (east), have been assessed against the statement of significance for the Bulwer Avenue Group. The concrete rendering has resulted in an irreversible repair that may lead to further damage to the original limestone and masonry once the concrete render is removed due to the binding nature of the concrete, limestone and brick. Furthermore, the removal of concrete render may not successfully reveal all original limestone and masonry to be in its condition prior to the 2017-18.

On the basis of the above, **element** recommends the owner of No. 3 Bulwer Avenue considers and complies with the following in order to rectify the undertaken rendering works:

- Appoint a professional heritage consultant and/or suitably qualified professional with a track record on maintaining or repairing heritage buildings. Sample of works must be approved by the City of Vincent, prior to commencing any future works to No. 3 Bulwer Avenue.

- Ensure that cleaning to original fabric is low pressure, non-abrasive and non-chemical;
- Ensure that repairs, including replacing missing or deteriorated fabric, to use like-for-like fabric, that does not involve the removal of, or damage to, the significant fabric of the building; and
